1
00:00:08,150 --> 00:00:04,789
at nasa's kennedy space center in

2
00:00:10,549 --> 00:00:08,160
florida technicians at launch pad 39a

3
00:00:12,950 --> 00:00:10,559
are working to repair small cracks on

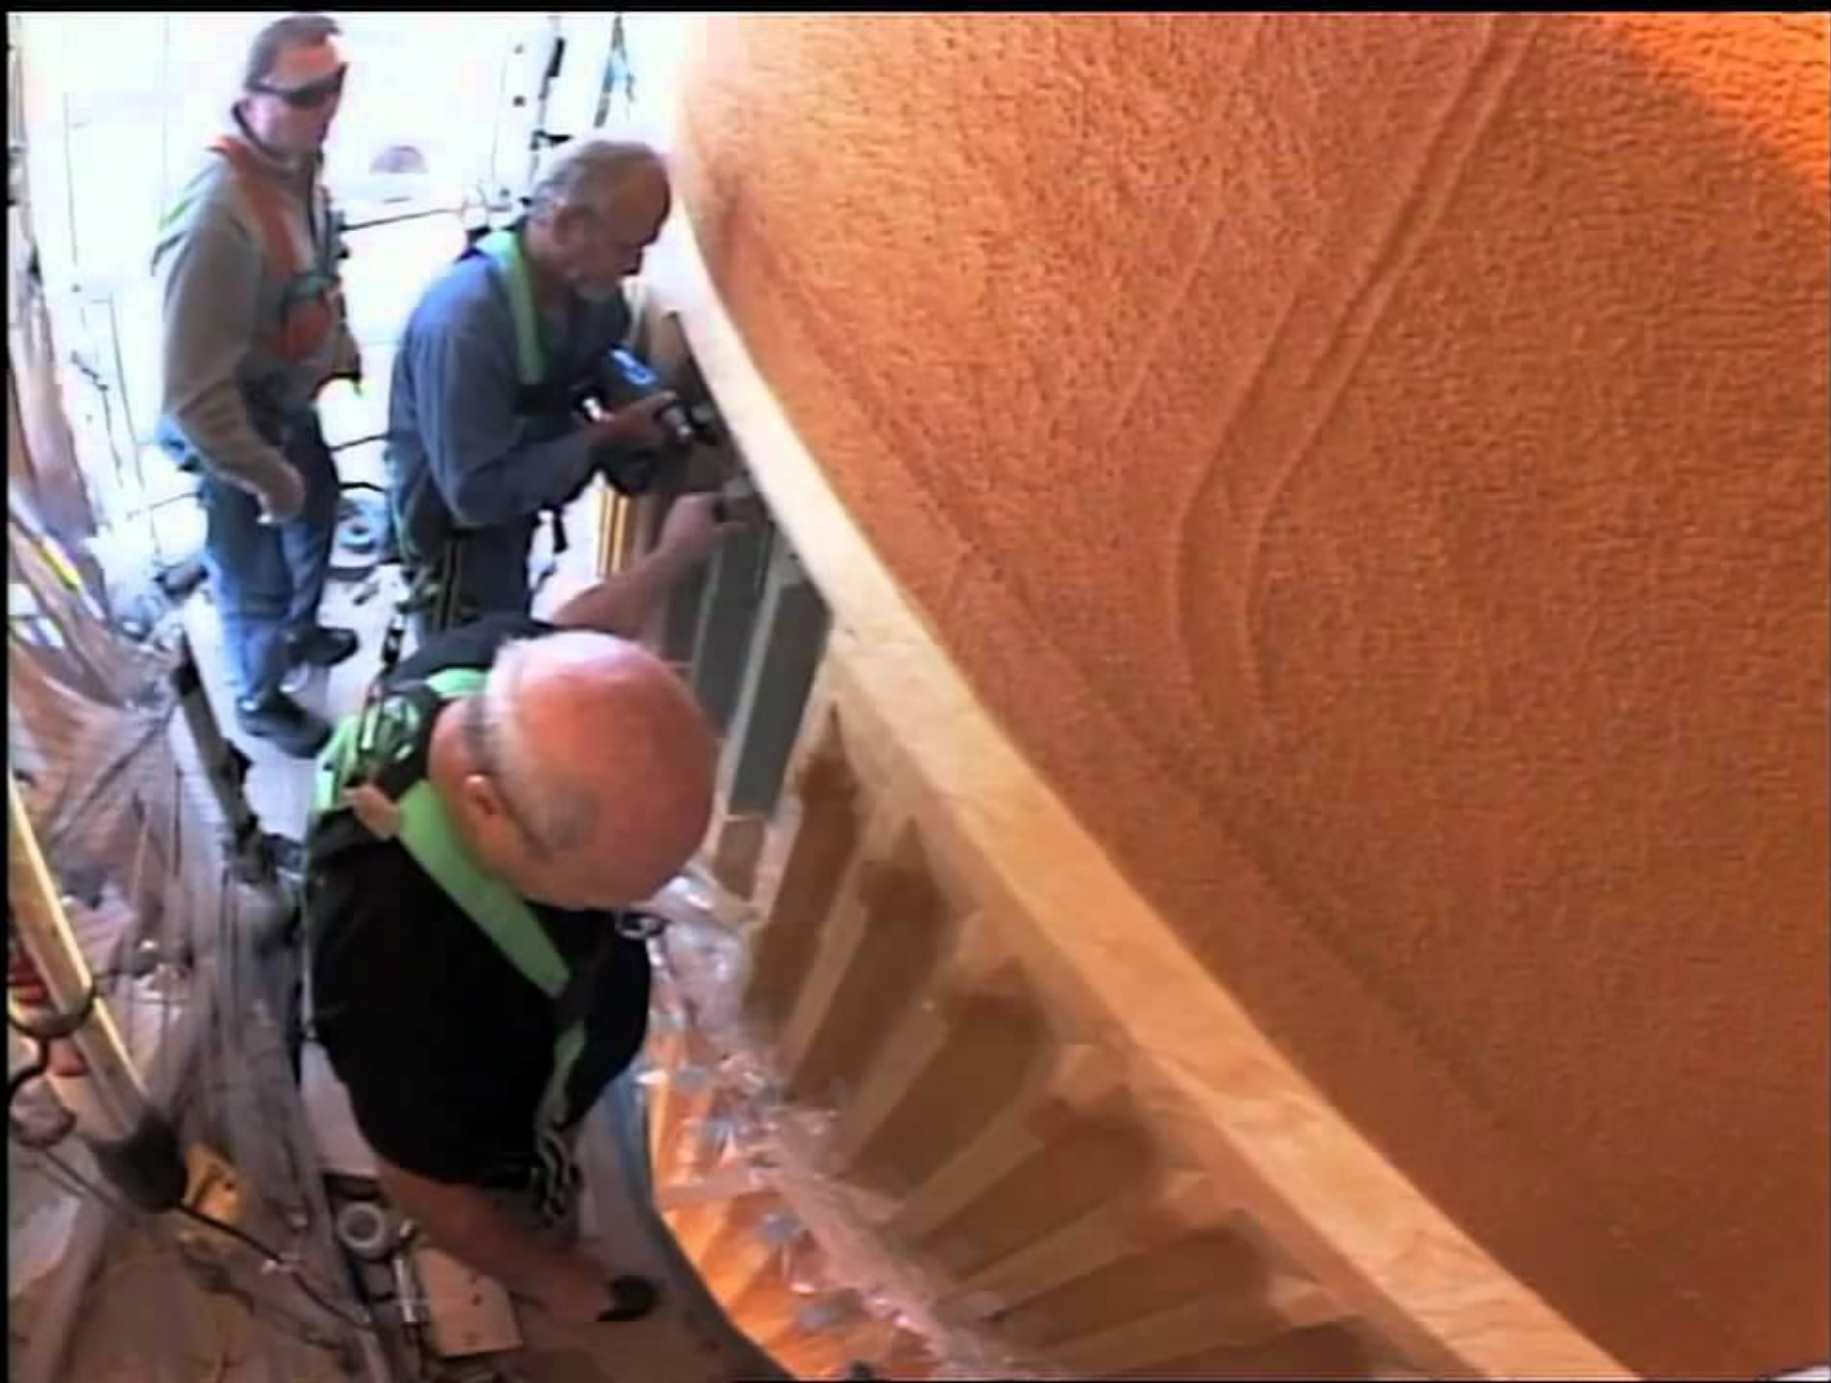
4
00:00:15,110 --> 00:00:12,960
the tops of two metal support beams

5
00:00:18,070 --> 00:00:15,120
called stringers on space shuttle

6
00:00:20,550 --> 00:00:18,080
discovery's external fuel tank

the stringer cracks developed as the

external tank was being filled for

discovery's launch attempt on november

7
00:00:22,630 --> 00:00:20,560
teams have removed 13 inches of metal

8
00:00:25,029 --> 00:00:22,640
from the tops of the two stringers and

9
00:00:27,670 --> 00:00:25,039
installed new sections of metal called a

10
00:00:30,310 --> 00:00:27,680
doubler in the cracked metal's place as

11
00:00:32,389 --> 00:00:30,320
part of the repair method
