# **Microscopic Changes In Bovine Tissues Exposed To Microwave Radiation, High Heat And Cauterization**

*National Institute for Discovery Science*

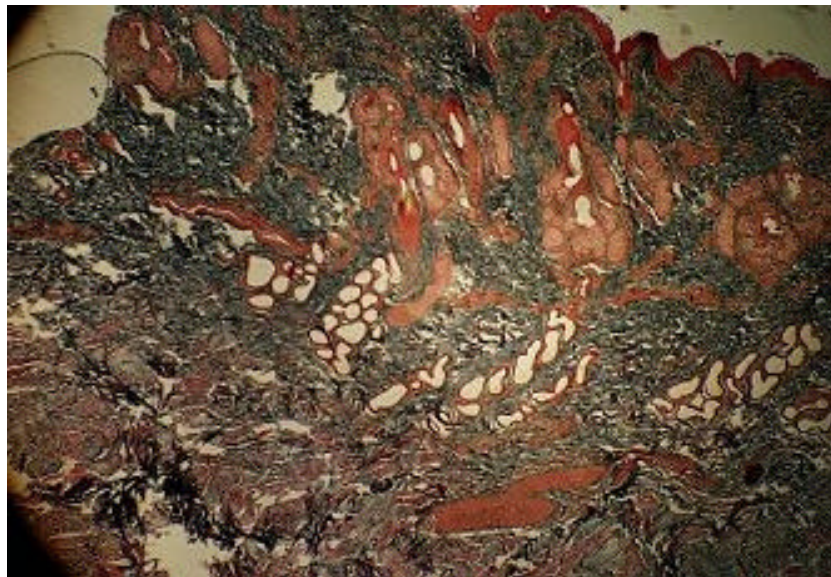
aluminum foil and non-protected. The exposed area displays a complete loss of cellular detail and stains an obvious pink color. This area is about five millimeters wide (Photo 5). There are thin areas of superficial dermis that have some blue collagen staining. The epidermis overlying these areas appears somewhat abnormal, with some vacuolation (Photo 6).

**Photo 5. Periorbital area skin, microwave exposure 15 seconds, x 22**

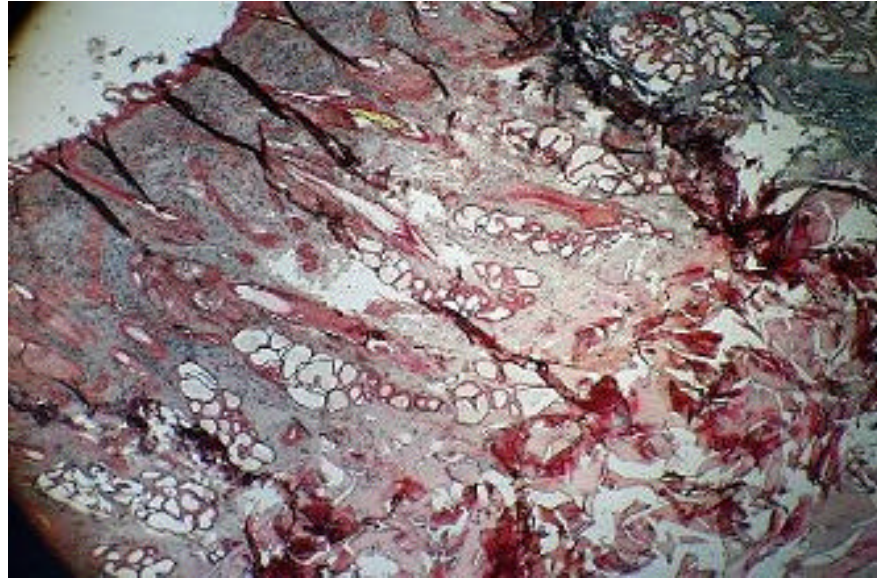
**Photo 6. Genital area skin, microwave exposure 15 seconds, x 22**

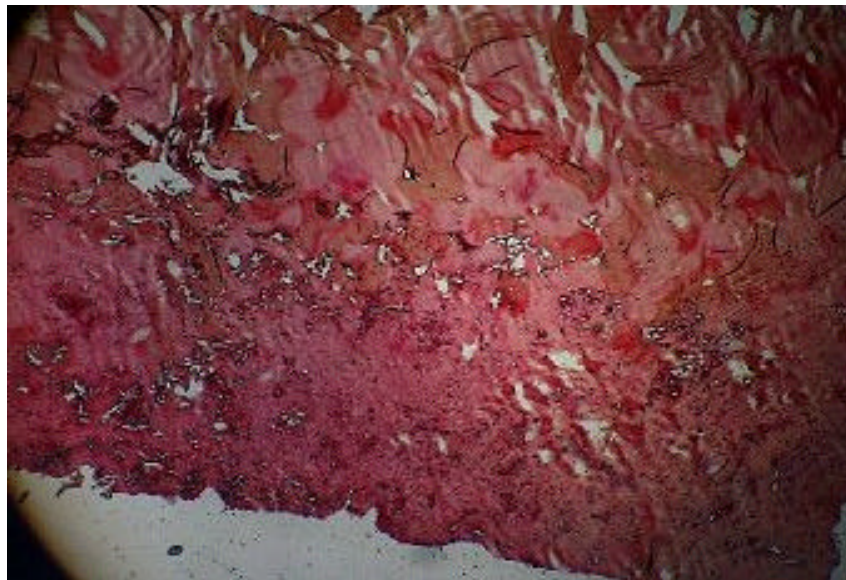
Thirty seconds of exposure results in complete destruction of the normal tissue architecture of the skin, from epithelium to the subdermic layers. The intense red coloring of the collagen makes it appear as amorphous red stained conglomerates. (Photos 9 and 10).

**Photo 9. Genital area skin, microwave exposure 30 seconds, x 22**

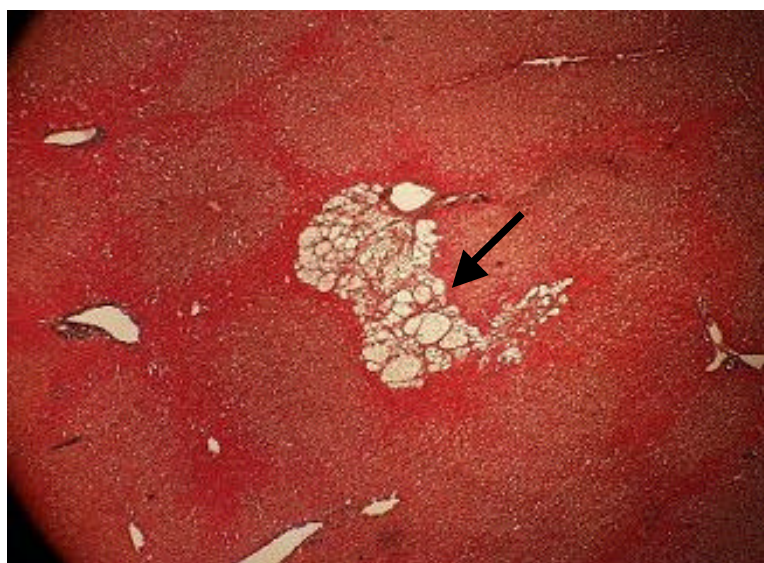
The liver tissue exposed to microwave radiation suffers important morphologic changes, which go from slight, uneven degeneration of the hepatic lobules to creation of numerous empty spaces close to the central vein (see arrow in Photo 11), or randomly disposed bubble-like formations, which dislocate the cords and disrupt the normal hepatocyte hexahedral arrangement (Photo 12). The hepatic cords become hard to distinguish and the sinusoids lose their normal anatomic disposition. Some of them display a pale staining. The exposed half of the sample shows a darker red staining, with loss of cellular detail and fragmentation of the parenchyma resulting in the appearance of numerous irregular vacuoles. The capsule over this portion is also stained red, with loss of the blue staining of collagen.

**Photo 11. Liver, microwave exposure 20 seconds, x 55**

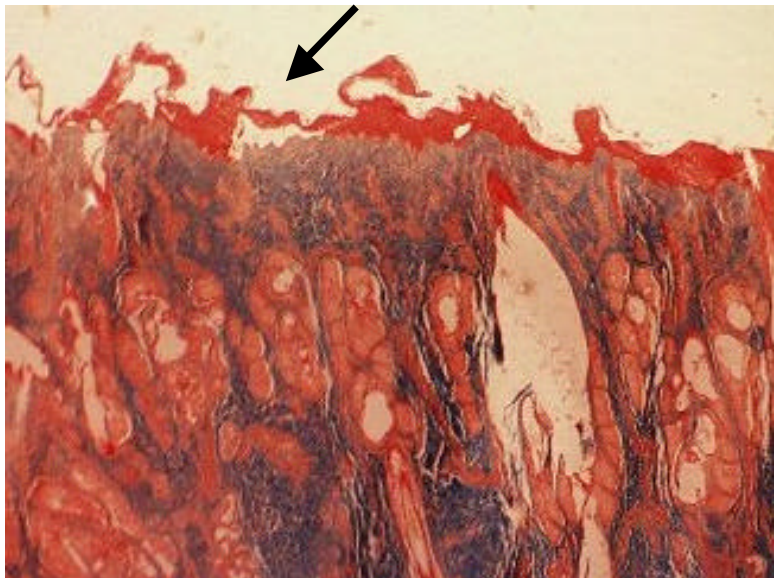
After 1 minute the epidermis and dermis appear not too much damaged and shows a red staining of the epithelial elements and blue staining of the collagen. The epithelium seems to have been dislocated and leaves some epithelial empty spaces (see arrow in Photo 13). The deep portion of the dermis extending into the subdermis has a non-stained appearance, with poor cell definition (Photo 14).

**Photo 13. Genital area skin, oven heat exposure 1 minute, x 15**

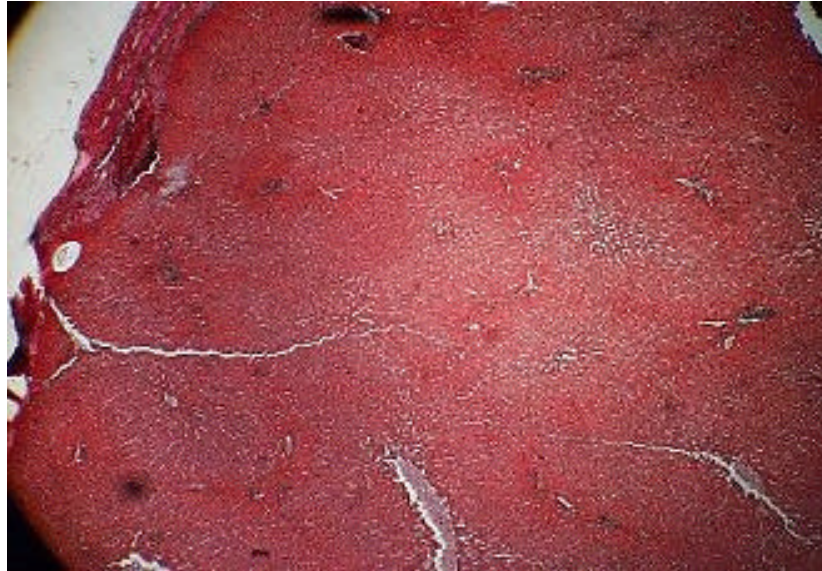
After 3 minutes of heat, exposure hepatocytes are more lightly stained and have no blue staining. This suggests that the collagen in the capsule as well as in the trabecular tissue extending into the parenchyma have lost their normal staining characteristics (Photo 18).

**Photo 18. Liver, oven heat exposure 3 minutes, x 22**
