**UNIDENTIFIED FLYING OBJECTS (UFO) FILES**

**File Title: Investigations of Unidentified & Radar Sightings  
East Coast South Island – December 1978**

REPORT ON UNIDENTIFIED VISUAL AND  
RADAR SIGHTINGS EAST COAST SOUTH ISLAND  
DECEMBER 1978

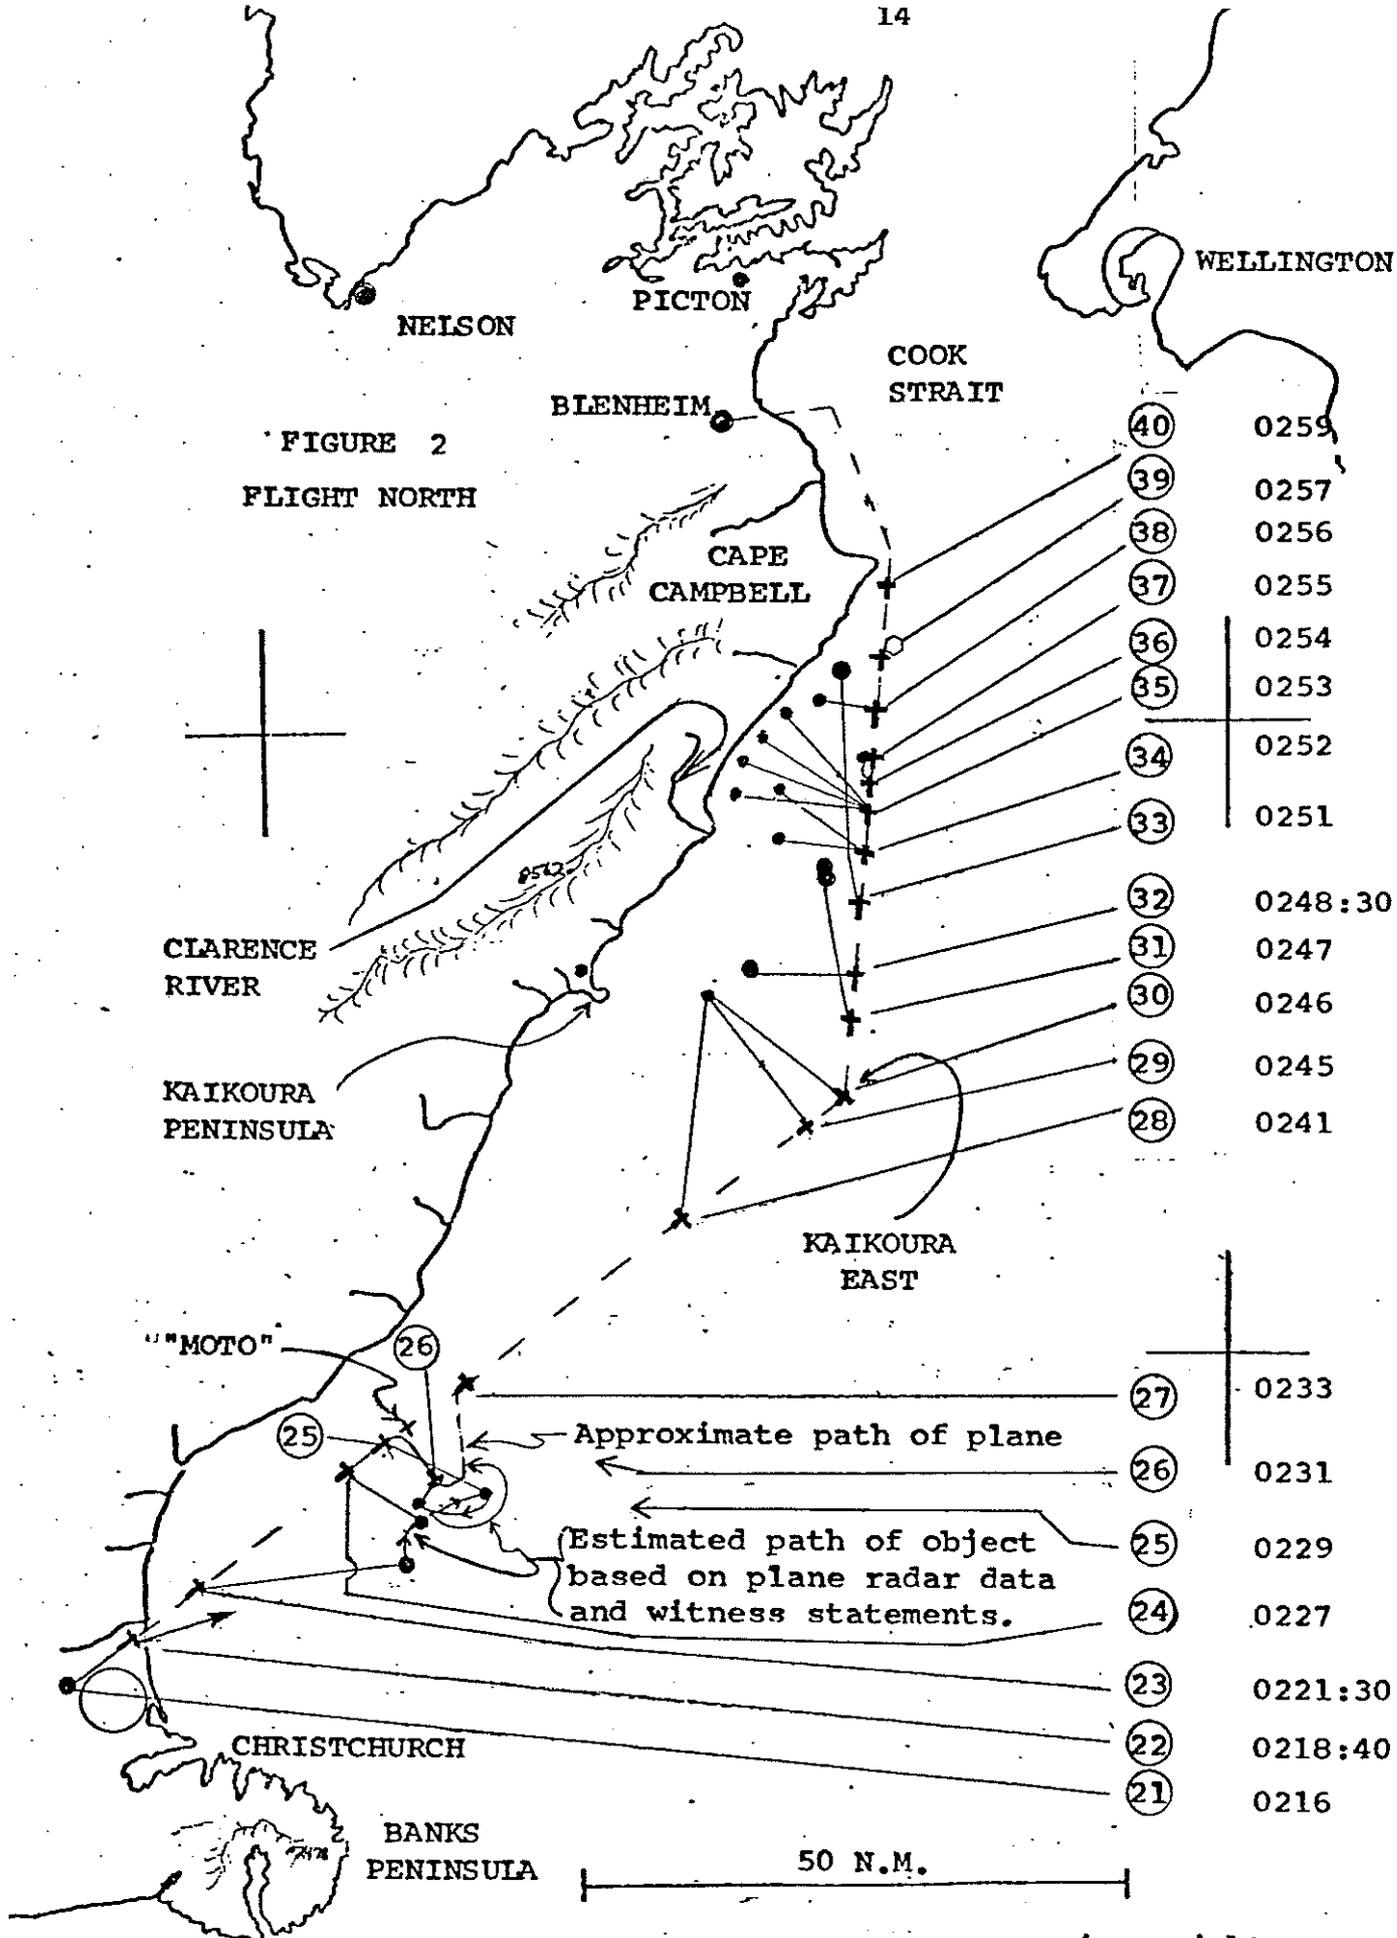
FIGURE 2  
FLIGHT NORTH

- 21 about 0216 : P took off from CH toward the northeast along the "MOTO" track toward Kaikoura East. The heading is 033 magnetic or 054° true (i.e., 54° clockwise from true north). DG had replaced NC. The climb rate was somewhat greater than 1000 ft/min, a number which decreased as the altitude increased, and the air speed was about 155 knots, a number which increased with altitude. There was a southwest wind of about 15 knots which added to the air speed of the aircraft.

- 22 about 0218:40 : the plane had travelled about 7 miles from CH and was not yet over the ocean. It was at an altitude of about 2800 ft, and was just breaking through a low cloud cover that was over the land. S, D, and DC, who were in the cockpit, observed a bright light through the cloud tops. The light was about 10-30° to the right of the airplane heading. The light was apparently about at the height of the plane. S's first impression was that he was looking at the full moon without seeing any features. (The moon had set in the west many hours before.) G described it as a "squashed orange". S turned on the airplane radar and placed it in the "mapping mode". About the time that the light was first seen DG and F, who had been sitting in seats in the loading bay during takeoff, arrived on the flight deck and G pointed out the light to them. This was at about 2:18 A.M. according to a note written down by DG. DG described the light (not necessarily his first impression) as looking like a ping-pong ball (white) that was in a dark room and illuminated by a spotlight. DG also recalled a light below the object which he attributed to a reflection on the ocean. (It might have been a reflection on clouds.) DC had filmed the takeoff from CH so he was ready to film and probably was filming at the time the F and DG arrived on the flight deck. F was now operating the recorder. H recorded: "We are now about 3 minutes out of Christchurch airport and on our starboard side we can see two very bright lights.....one much brighter than the other. The only way to describe it.....it's like a very very bright star

- 25 about 0229 : the plane reached the cruising altitude of about 13,000 ft and an air speed of 215 knots. S and G decided to turn to the right toward the object to see what would happen. S made a turn that lasted about 45 seconds. He hadn't expected to have to turn very far, suggesting that the object was not directly to the right of the aircraft, but was still somewhat ahead. However, he found that he had to keep turning and he finally stopped when he had turned about  $90^{\circ}$  to the right. Before the turn started F recorded "The pilot has just told us he is going to actually level off.....and head toward the object to see what happens." During the turn F recorded the apparent motions of the object, not realizing that the turning of the plane made it look as if the object were moving up and then down and then to the front of the aircraft. After the turn was completed the sighting line to the object was ahead and downward. DG wrote a note " 2:30 A.M., directly ahead, no radar reading " The fact that it was not seen on the radar scope even though it was ahead of the airplane suggests that the sighting line to the object must have been considerably lower than  $15^{\circ}$  below horizontal, which is the nominal lower bound of the radar beam in the mapping mode. (The pilot did not try to increase the tilt of the radar beam.) If the sighting line had been at an angle of  $20^{\circ}$  below horizontal and the object had been at an altitude of 3000 ft. while the plane was at 13,000 ft. the distance to the object would have been about 5 miles. G had the impression that the plane had "overflown"

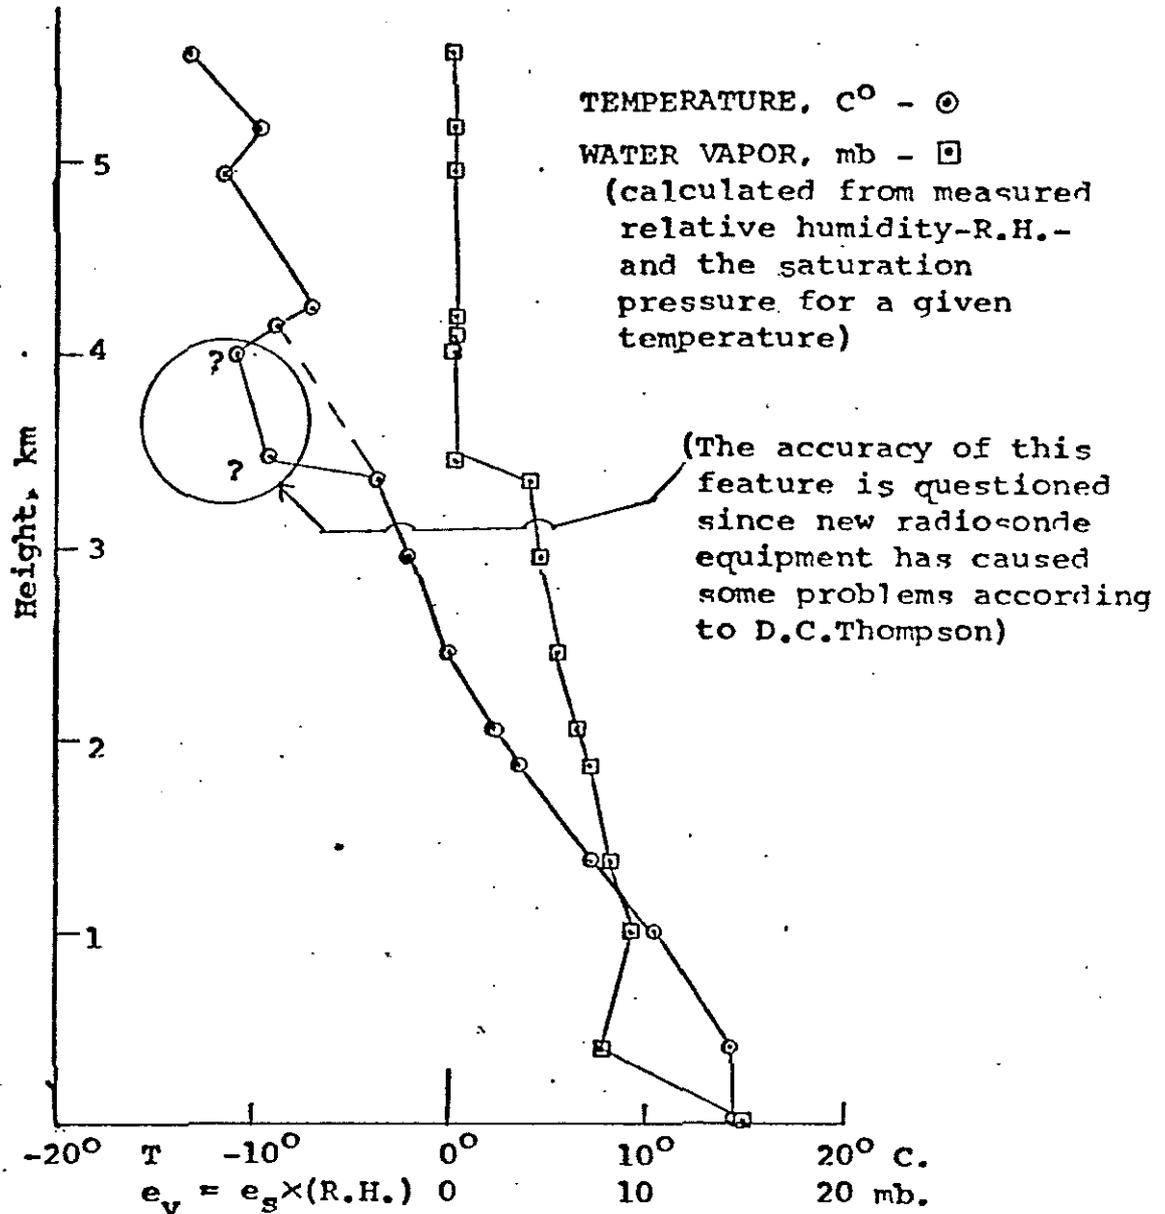
FIGURE 3

## TEMPERATURE AND HUMIDITY

VERTICAL STRUCTURE OF THE ATMOSPHERE FOR  
 CHRISTCHURCH, N.Z. from the 11:00 P.M.  
 balloon launching, Dec. 30, 1978. Data  
 supplied by J.T. Steiner, Ass't. Dir.  
 for Research and D.C. Thompson, Superintendent  
 Physical Meteorology ; N.Z. Meteorological  
 Service, Wellington, N.Z.

WEATHER: (as determined by the flight crew) excellent flying conditions with no noticeable departure from a standard temperature lapse rate from ground level to 14,000 feet; low clouds over Wellington; visibility about 60 km over the sea; wind speed at cruising altitude estimated to be no more than 10-15 knots from the west; atmospheric conditions sufficiently steady to allow operation with automatic pilot and automatic height control (as pressure sensitive device); no noticeable inversion effects on Wellington radar. The temperature and humidity variations with altitude are shown in Figure 3.

WEATHER: (as determined by the flight crew): excellent flying conditions with no noticeable departure from standard lapse rate conditions; wind speed at cruising altitude estimated at 10-15 knots from the southwest; possibly a cloud bank more than 40 miles east of the South Island: low cloud cover 1200 to about 3000 ft. above Christchurch; scattered low cloud over ocean; CAVU conditions above clouds; for Blenheim at about 2:45 am the wind was out of the northwest at 10-15 knots, the visibility was 60 km, the cloud cover was 1/8 at 4,000 ft, and the temperature was 15°C; after achieving the cruising altitude the crew operated the plane on automatic height control. (See also Figure 3.)

evening (see Fig. 3). Refractive bending of the radar beam is caused by the variations in air pressure, temperature, and humidity with altitude. The amount of bending to be expected for a particular temperature-pressure-humidity "structure" of the atmosphere can be estimated by calculating the radar refractivity profile. Fig. 4 shows the profile calculated from data in Fig. 3. Radar ray curvatures in seconds or arc per kilometer are also illustrated in the figure. Only for a small height region around 3400 meters was the refractivity sufficient to make a ray follow the curvature of the earth. Nowhere was the refractivity great enough to bend a ray as much as a minute of arc per kilometer of distance travelled. A ray which travels 10 km through a medium that bends it downward from a starting angle of  $5^\circ$  upward would be only about 30 meters lower in altitude if the bending rate is 2 minutes per kilometer than it would be if the bending rate were 0.0 minutes per kilometer (no bending). Thus one can see that the effect of the curvature is small. The same ray would rise to a peak altitude of about 6.5 km after travelling about 150 km (assuming the refractivity gradient is constant up to that altitude) and then it would bend downward and intersect the earth at a point about 300 km from where it started at the earth's surface. A ray that started off at a steeper angle would go farther before reaching the earth's surface, and one that starts off at an angle of less than  $5^\circ$  would not go as far.

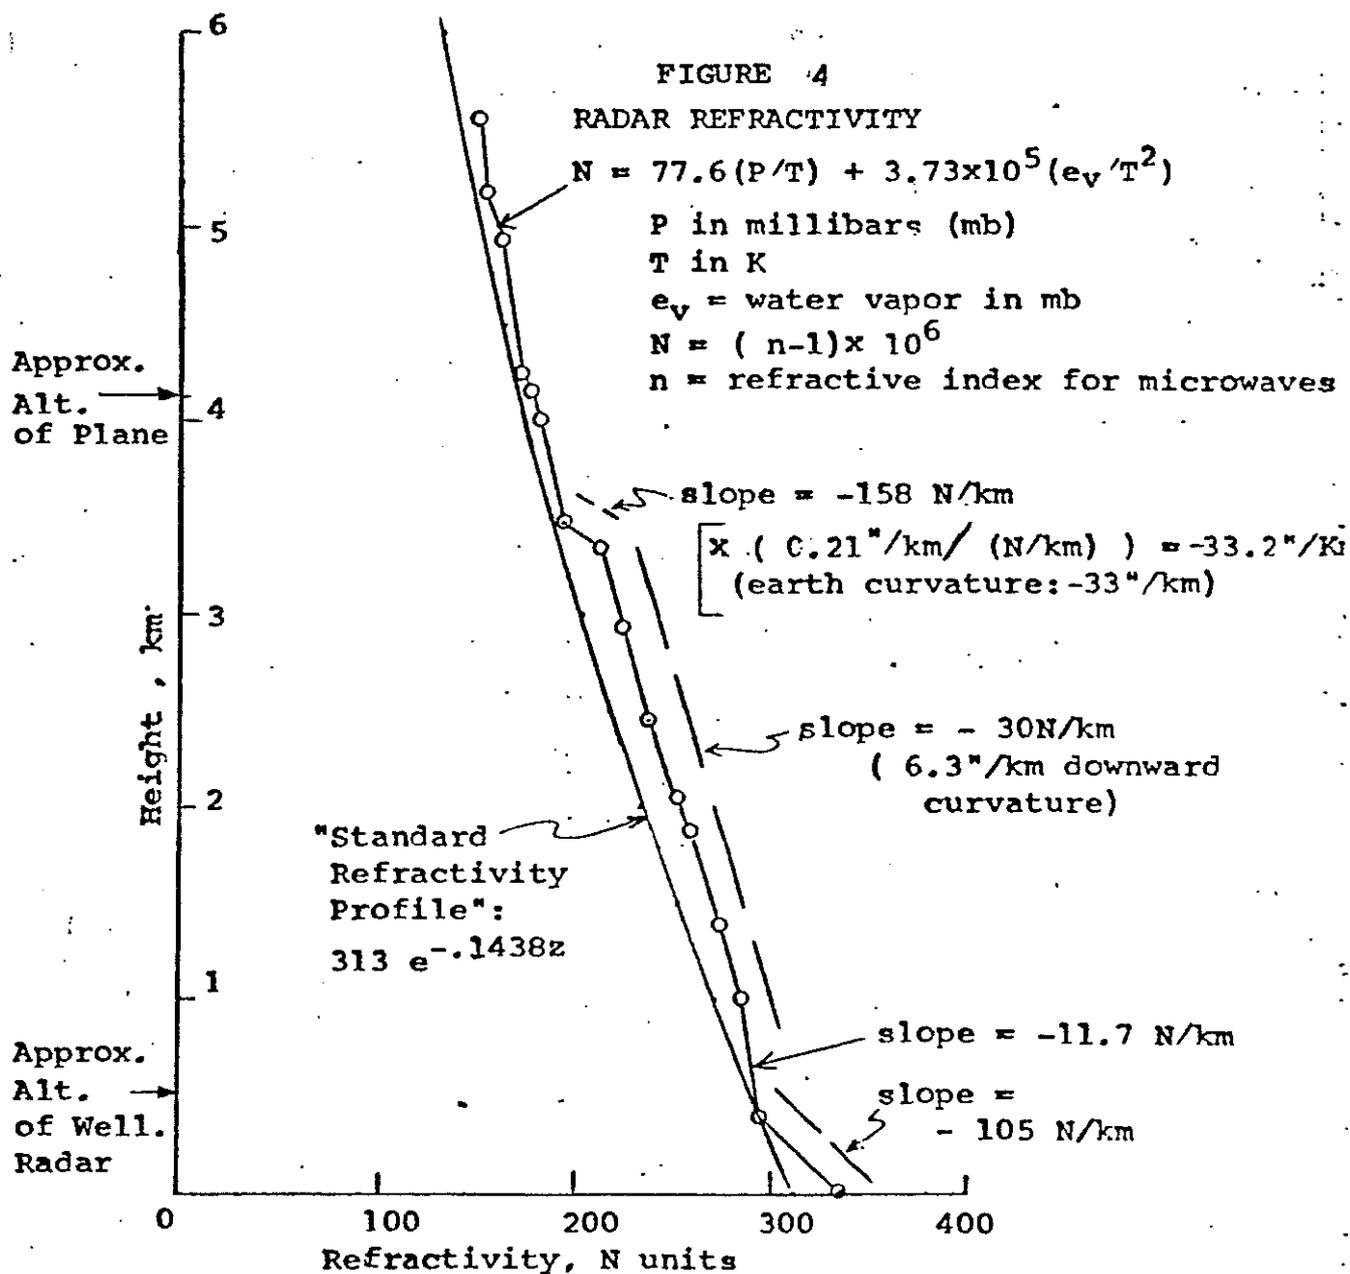
## REFRACTIVITY PROFILE FOR CHRISTCHURCH, N.Z.

From the 11:00 P.M. balloon launching, Dec. 30, 1978.

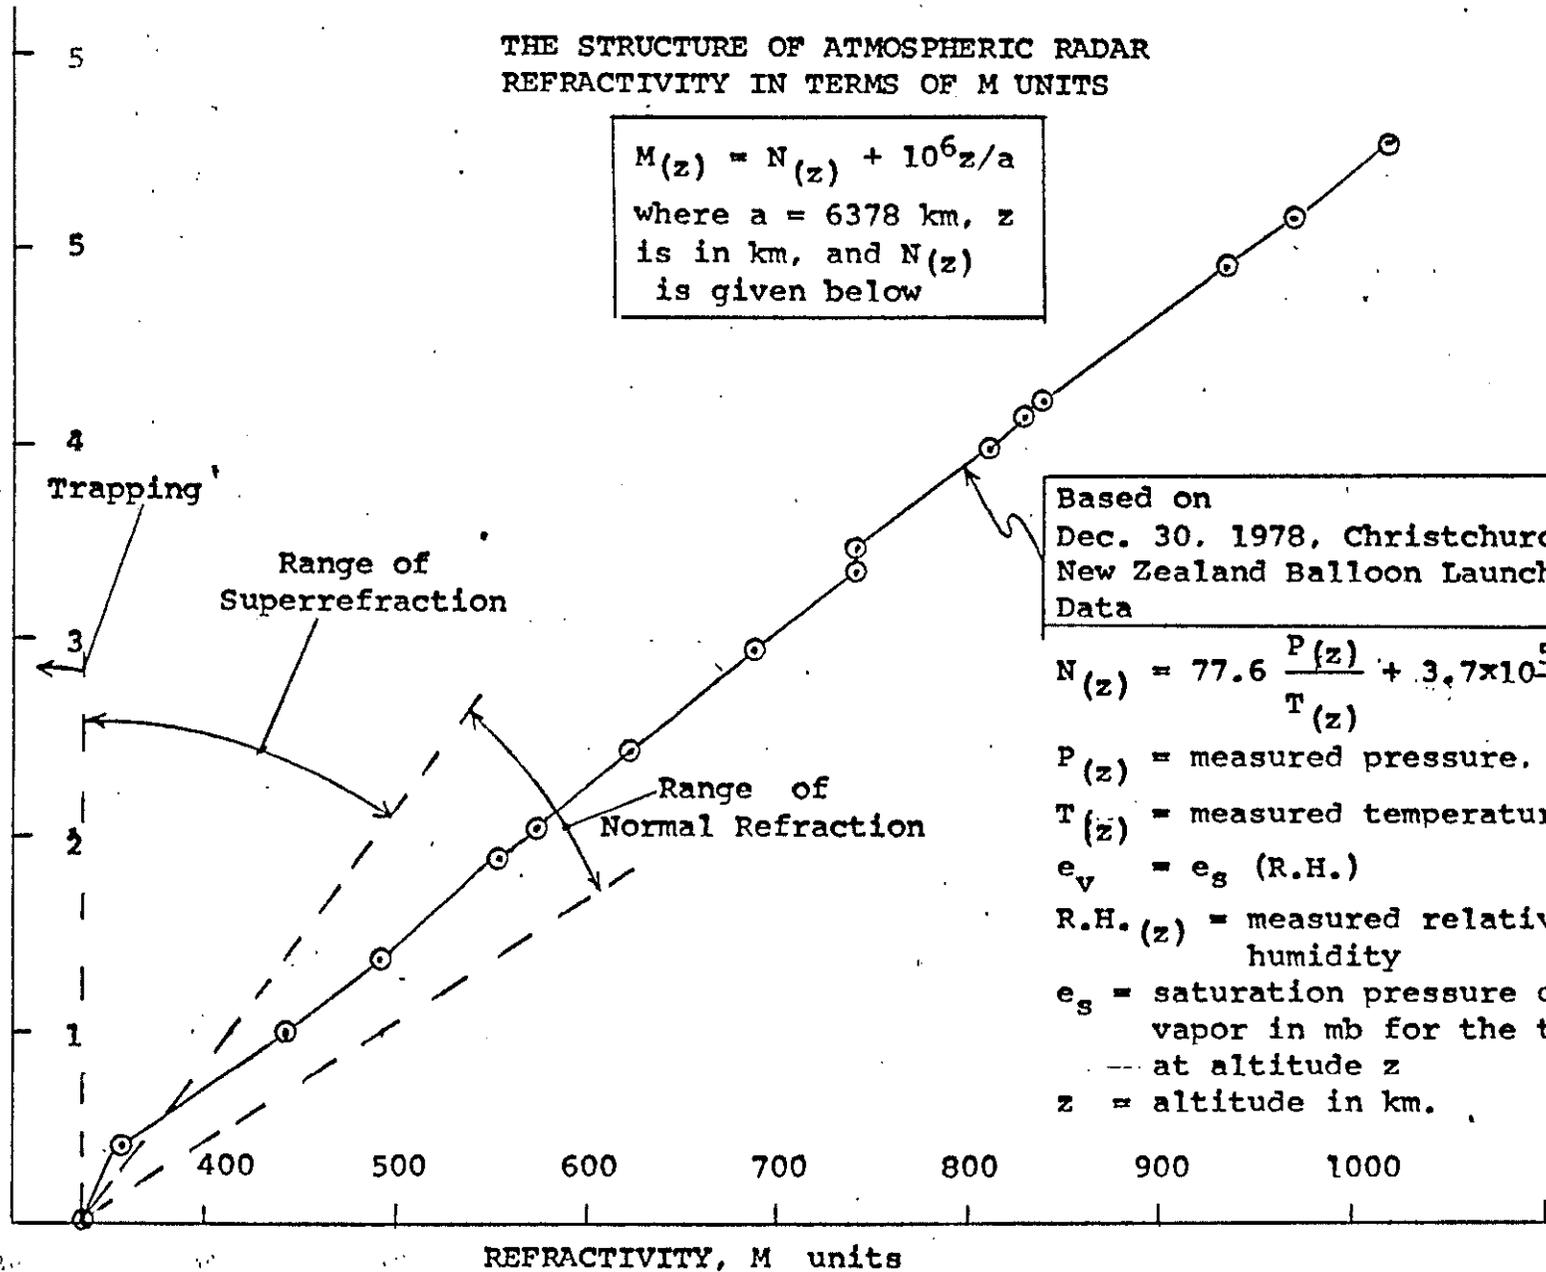
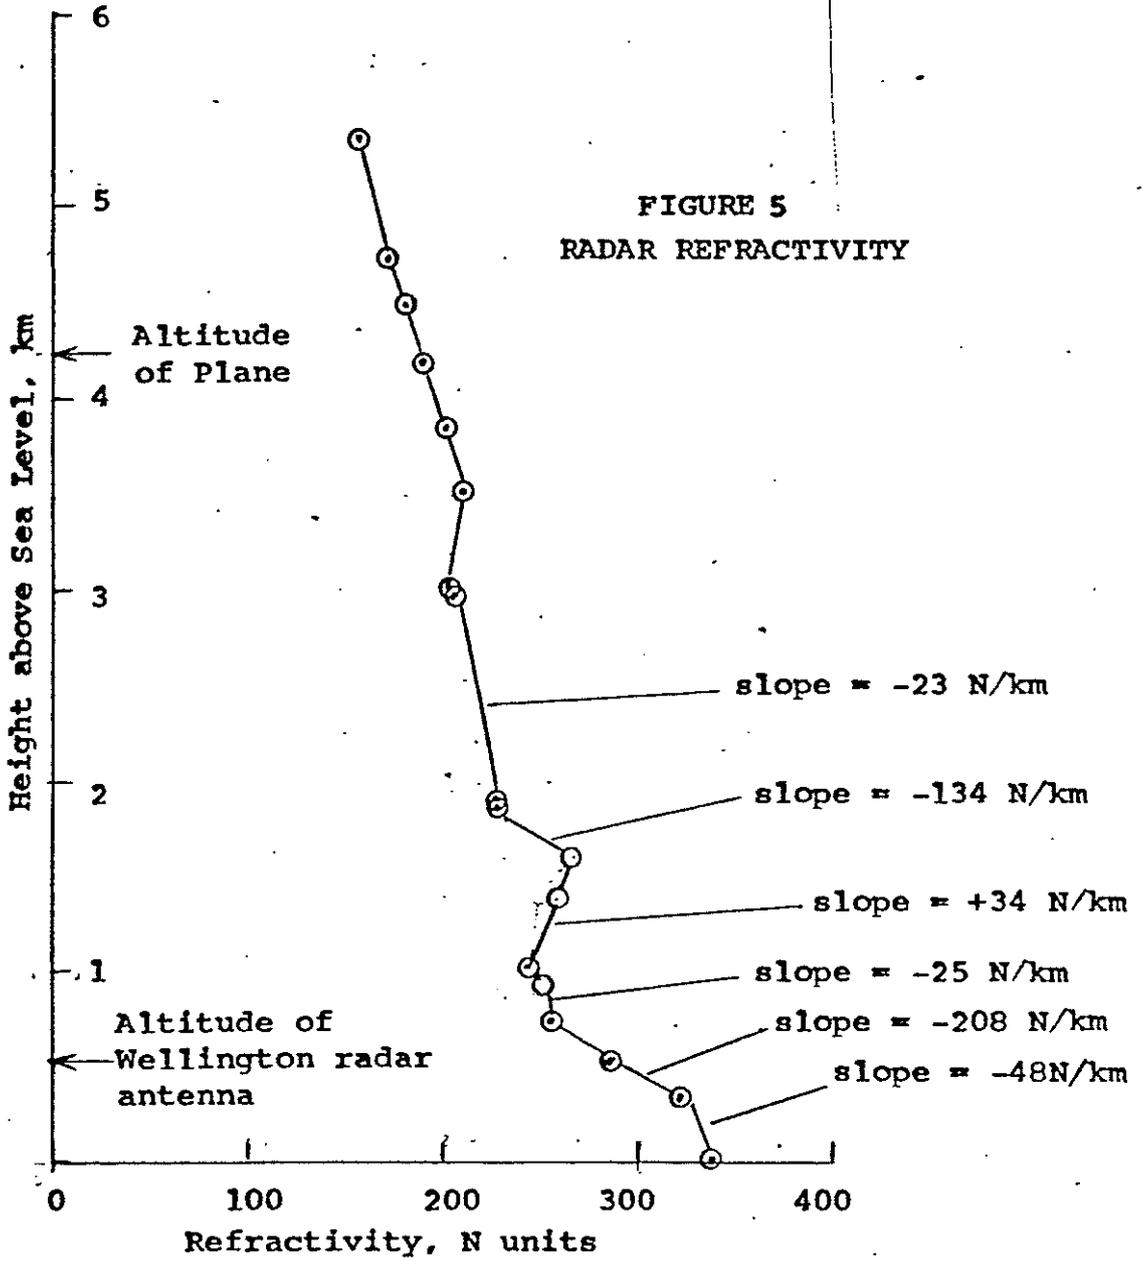
REFRACTIVITY PROFILE FOR CHRISTCHURCH, N.Z.  
From the 11:00 PM balloon launching, Dec. 20, 1978

(For comparison, Fig. 5 shows the refractivity profile for the early morning of the 21<sup>st</sup> of Dec. Note that there is a sufficient refractivity gradient in the first kilometer to cause some trapping of radiation near the earth's surface. One might expect a non-MTI display to show ground and sea clutter at greater distances than would be normal.)

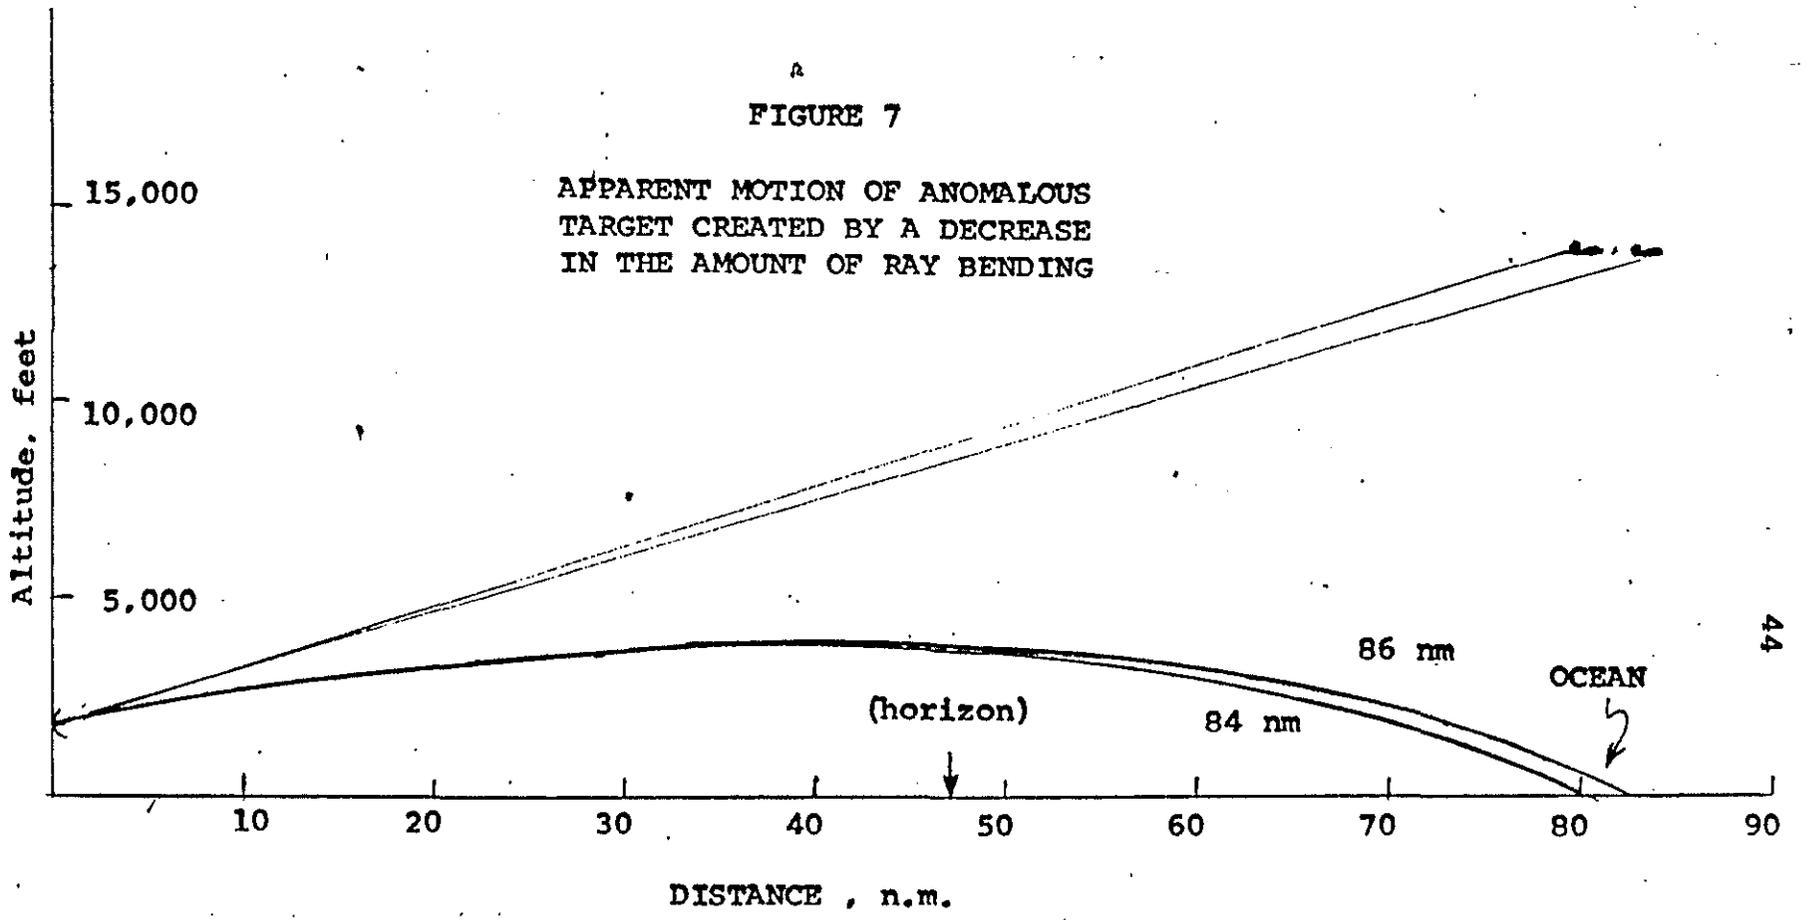
A  
FIGURE 7

APPARENT MOTION OF ANOMALOUS  
TARGET CREATED BY A DECREASE  
IN THE AMOUNT OF RAY BENDING

The big problem with all of these explanations requiring ray bending is that, when conditions are correct to that "one" ray or "ray bundle" bends down and hits the ocean, or a ship on the ocean, many adjacent bundles also bend down. Thus one would

expect not one but many apparently real targets at various azimuths and distances all moving at various apparent velocities as the conditions of the atmosphere change. Moreover, when the conditions of the atmosphere are such that noticeable ray bending is taking place and producing sea clutter, the random targets appear on a non-MTI presentation as well as on the MTI presentation. Yet BC saw no evidence of anomalous propagation. Thus it appears to be difficult to ascribe this particular radar incident to anomalous propagation. It is also difficult to ascribe the other "class" of unusual radar targets, those that remained stationary for long periods of time (minutes) to anomalous propagation since stationary targets produced by ray bending are, nevertheless, stationary, and therefore should not be able to defeat the MTI processing.

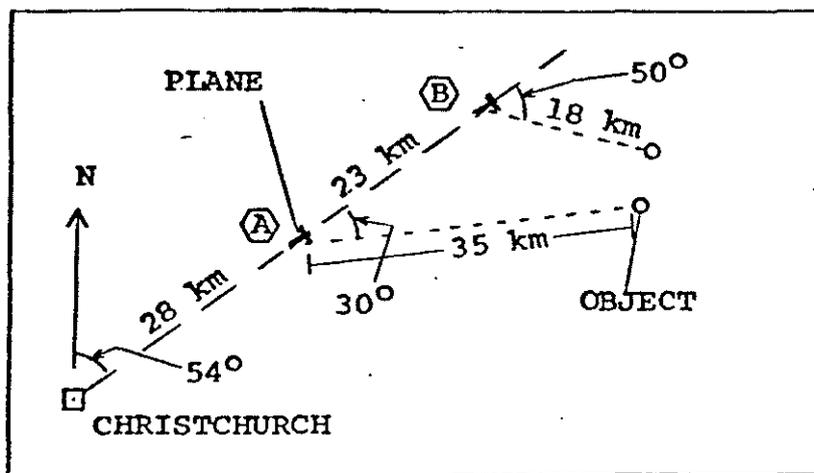
FIGURE 1

Figure 1 Relative positions of the airplane and the bright object during the period of radar detection. The plane travelled along the path indicated by the dashed line. The altitude of the plane increased from about <sup>1800</sup>1500 m at point A to about <sup>2000</sup>2600 m at point B.

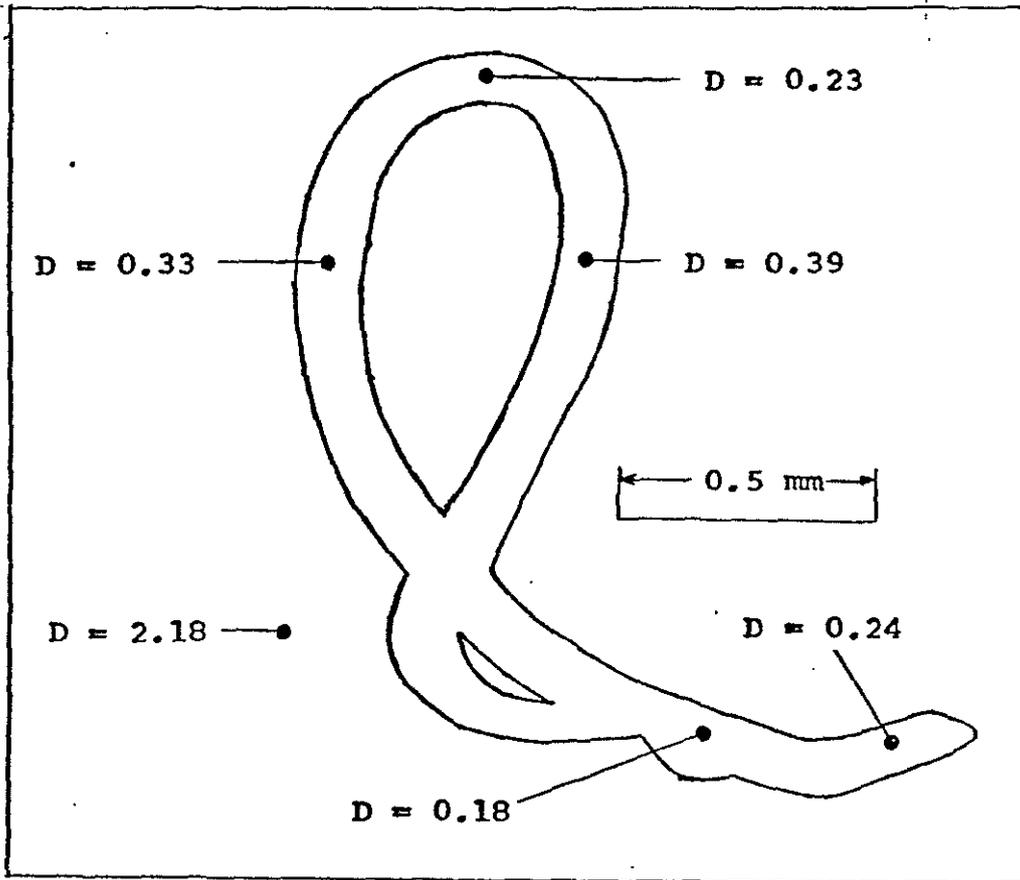
FIGURE 2

Figure 2 Tracing of the smeared image on a single frame from the New Zealand film of December 31, 1978. The background neutral density is about 2.18, as it is for preceding and succeeding frames. The time duration of the frame was about 0.044 sec. The bright yellow-white color is consistent with the witness descriptions.

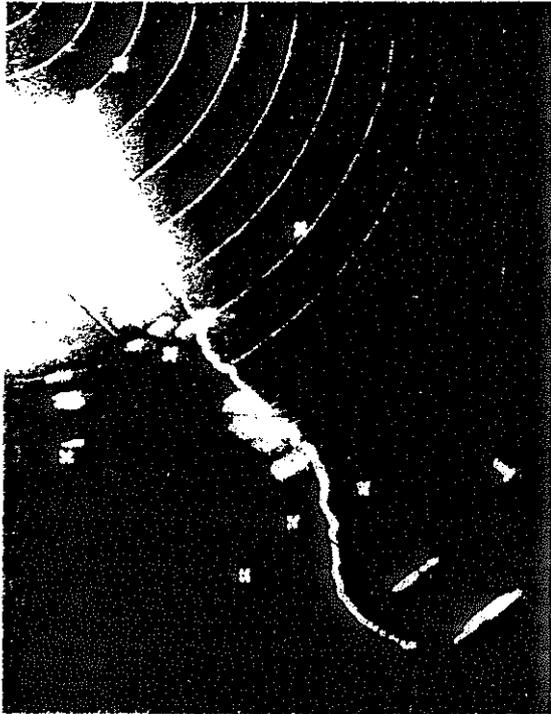
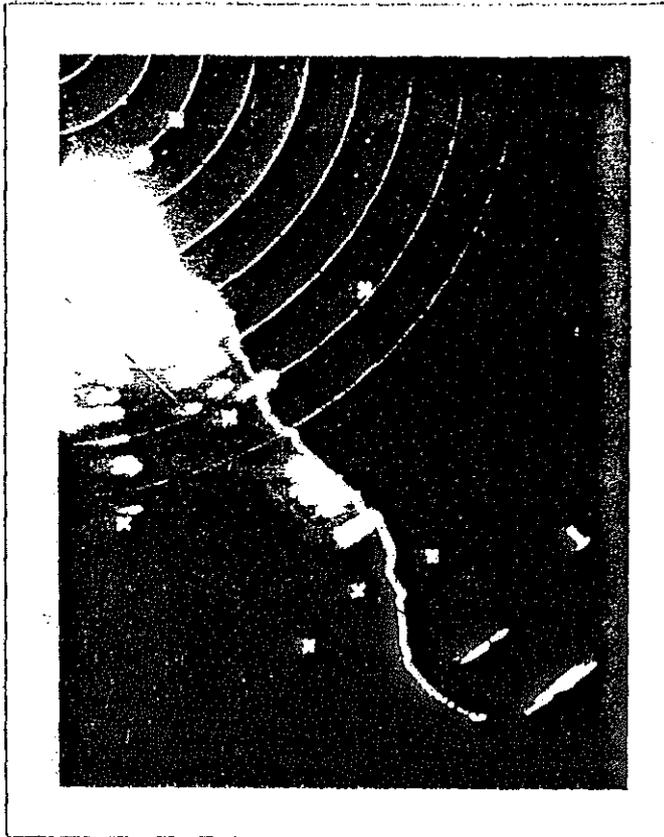
0330. RAW VIDEO. 160 MI.

BANKS PENINSULA RETURN  
AT MAX<sup>m</sup> RANGE

TWO ANOMALOUS ECHOES  
15 MI. NORTH OF BANKS P.

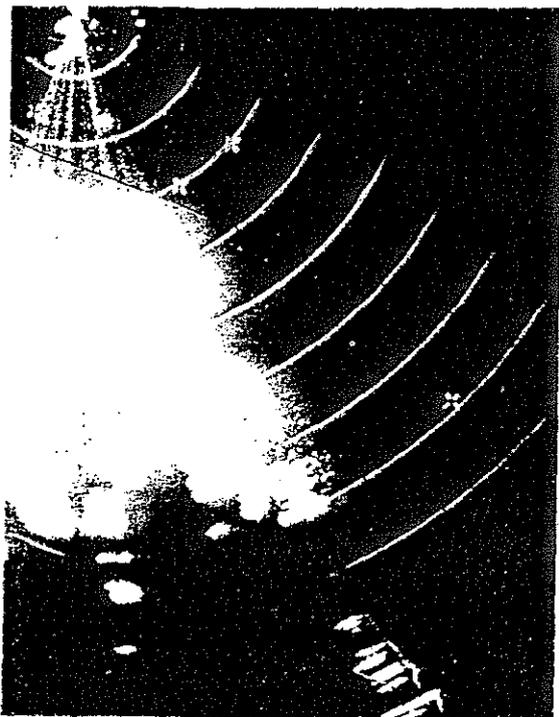
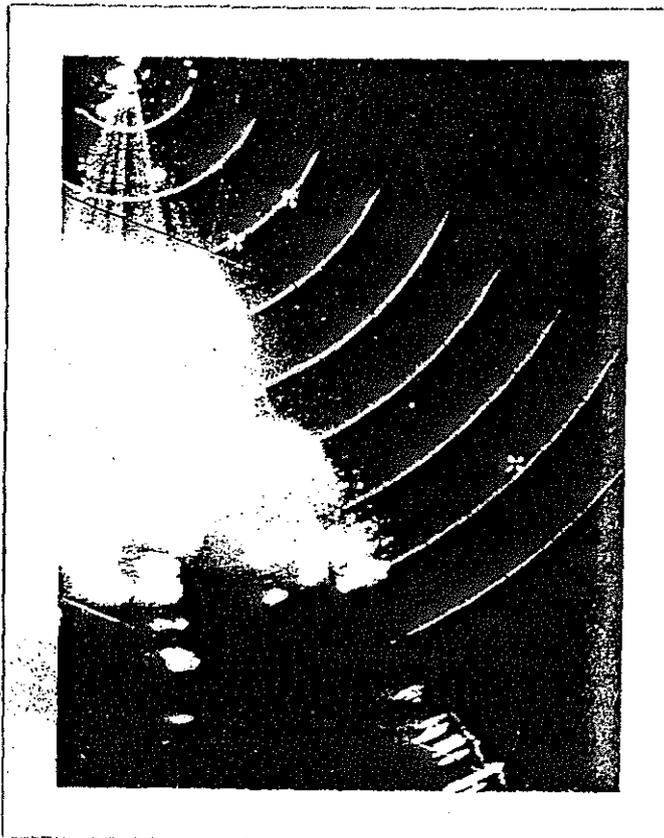
0450. RAW VIDEO 90 MI.

"RAIN" ECHOES OVER KAIKOURA

POSSIBLE SHIP AT 18 MI.

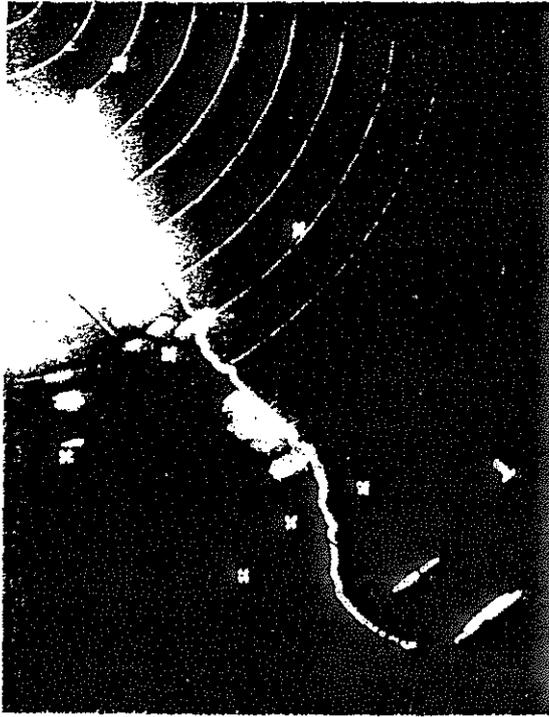
0333. RAW VIDEO. 160 MI.  
BANKS PENINSULA RETURN  
AT MAX<sup>m</sup> RANGE

TWO ANOMALOUS ECHOES  
15 MI. NORTH OF BANKS P.

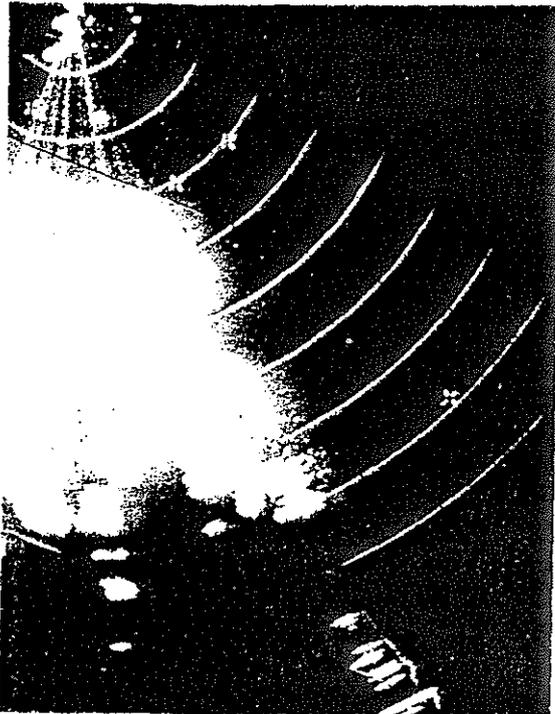
0450. RAW VIDEO 90 MI.

"RAIN" ECHOES OVER KAIKOURA

POSSIBLE SHIP AT 18 MI.

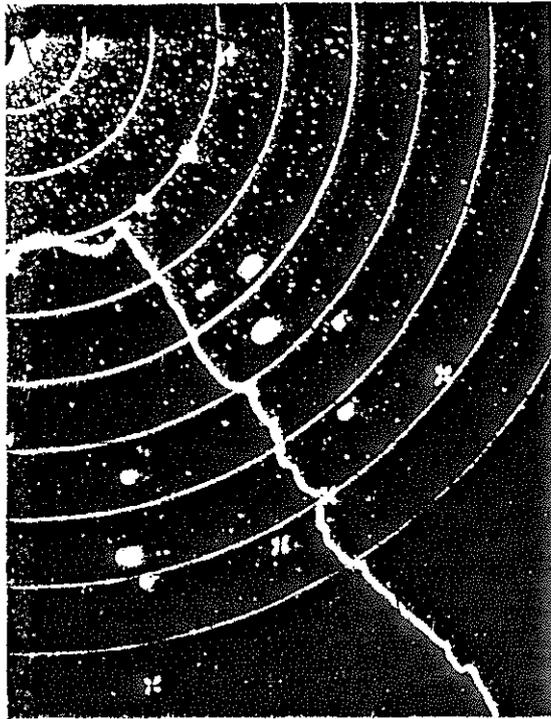
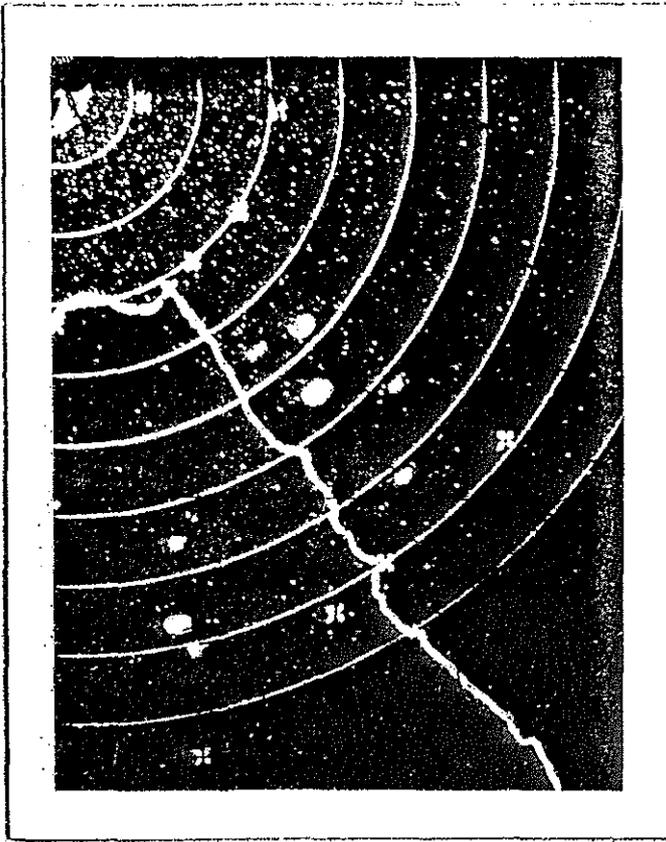
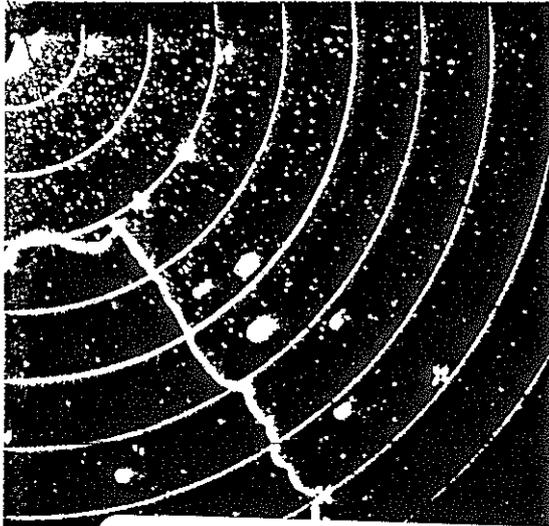
0219. M.T.I. 10 MI CIRCLES  
 TRIPLE ECHO POSSIBLY SHIP  
 AT 46 MI.  
 ALL OTHER ECHOES (8)  
 ANOMALOUS.

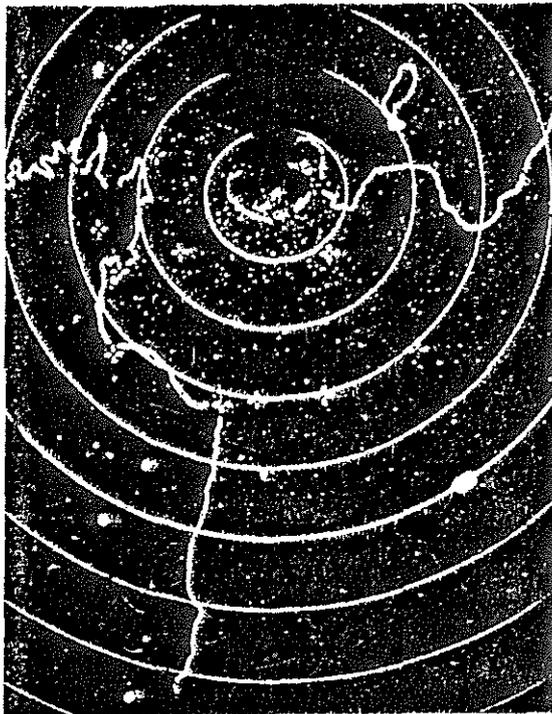
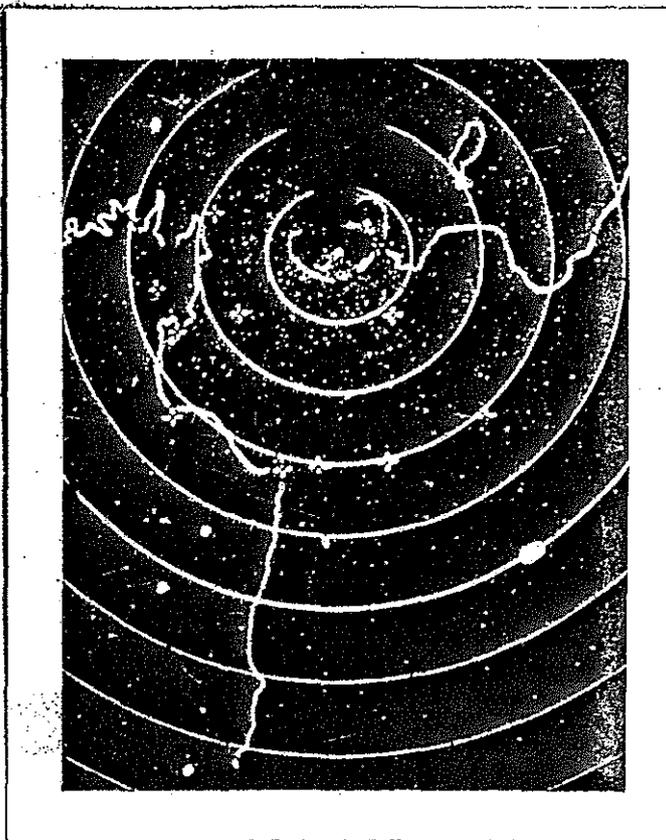
0436. M.T.I. 10 MI CIRCLES  
 SHIP OFF SOUNDS 36 MI.  
 ANOMALOUS ECHO AT 172°  
 50 MI, MOVING RADIALLY  
 OUTWARDS 100-150 KT.

The most interesting example was seen to be moving radially outwards at  $172^{\circ}$  at an erratic 100-150 knots for 10-15 minutes. It was 50-60 N.MILES from Wellington. Although we did not notice when it first became visible, it disappeared quite quickly at about 0445.
