**UNIDENTIFIED FLYING OBJECTS (UFO) FILES**

**File Title: Investigations of Unidentified & Radar Sightings  
East Coast South Island – December 1978**

REPORT ON UNIDENTIFIED VISUAL AND  
RADAR SIGHTINGS EAST COAST SOUTH ISLAND  
DECEMBER 1978

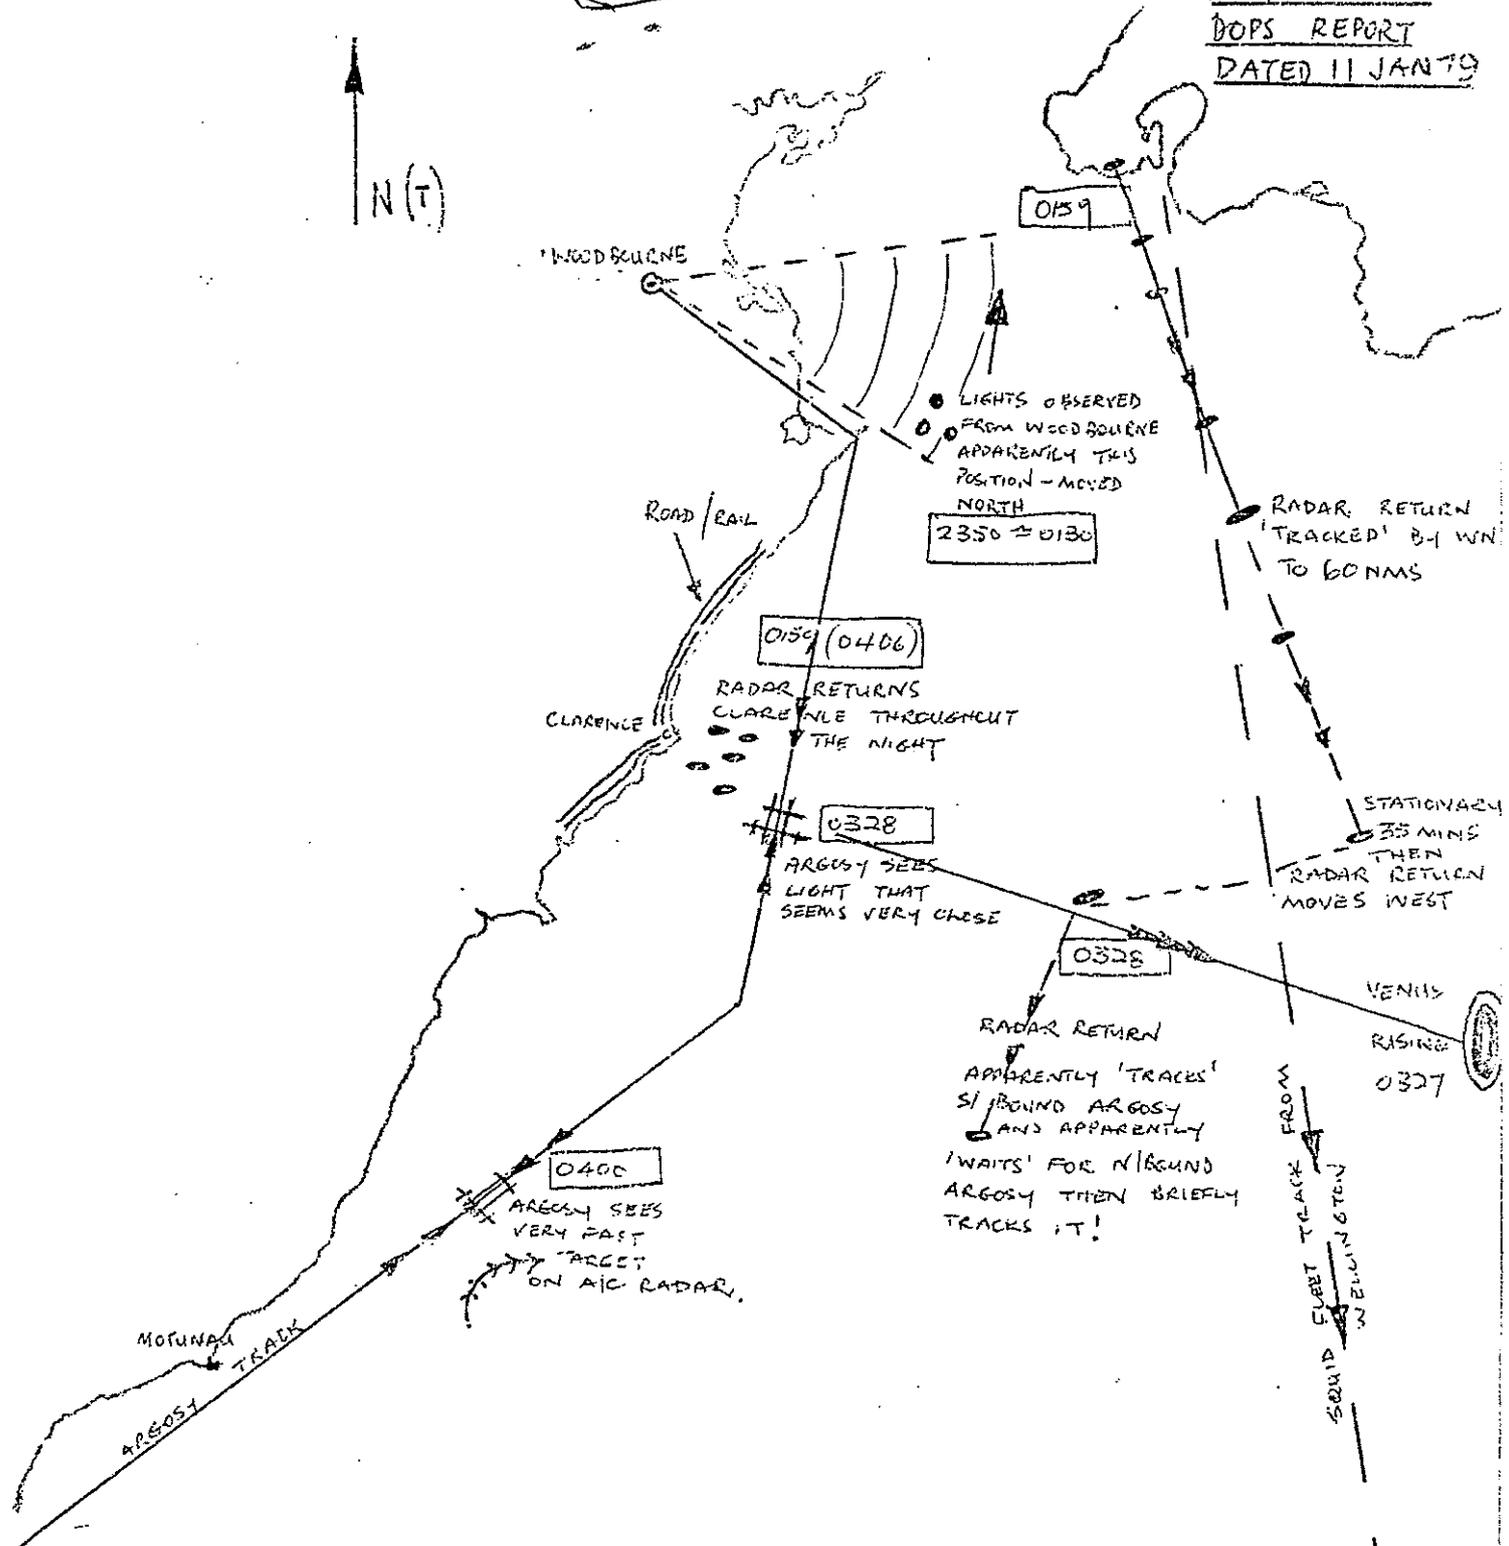
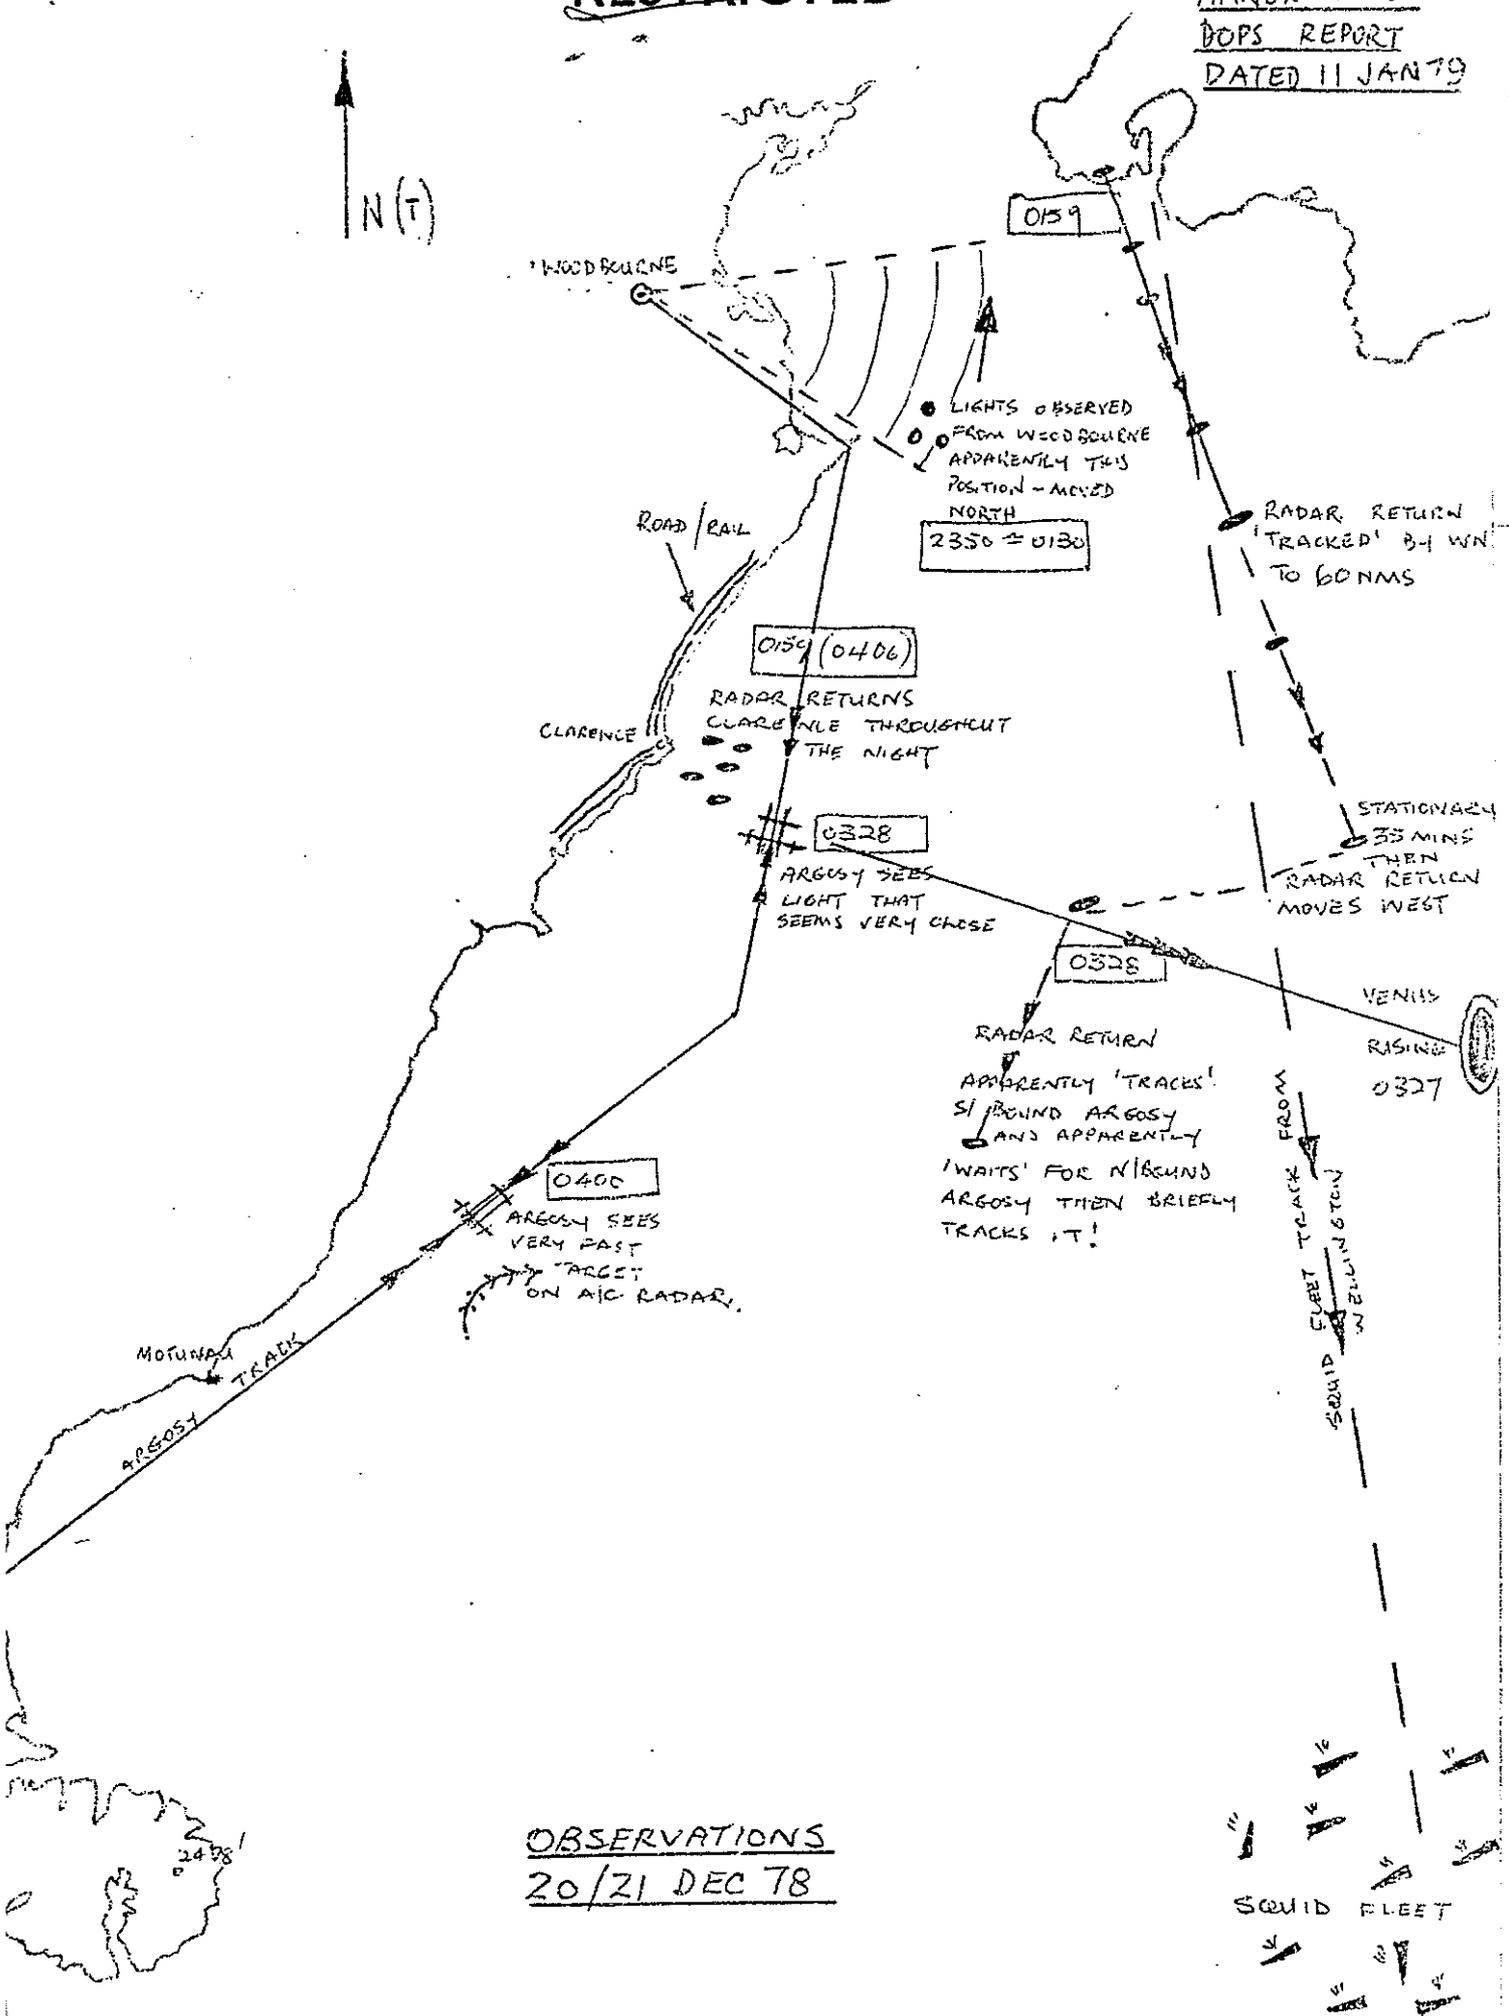
ANNEX A TO  
DOPS REPORT  
DATED 11 JAN 79

OBSERVATIONS  
20/21 DEC 78

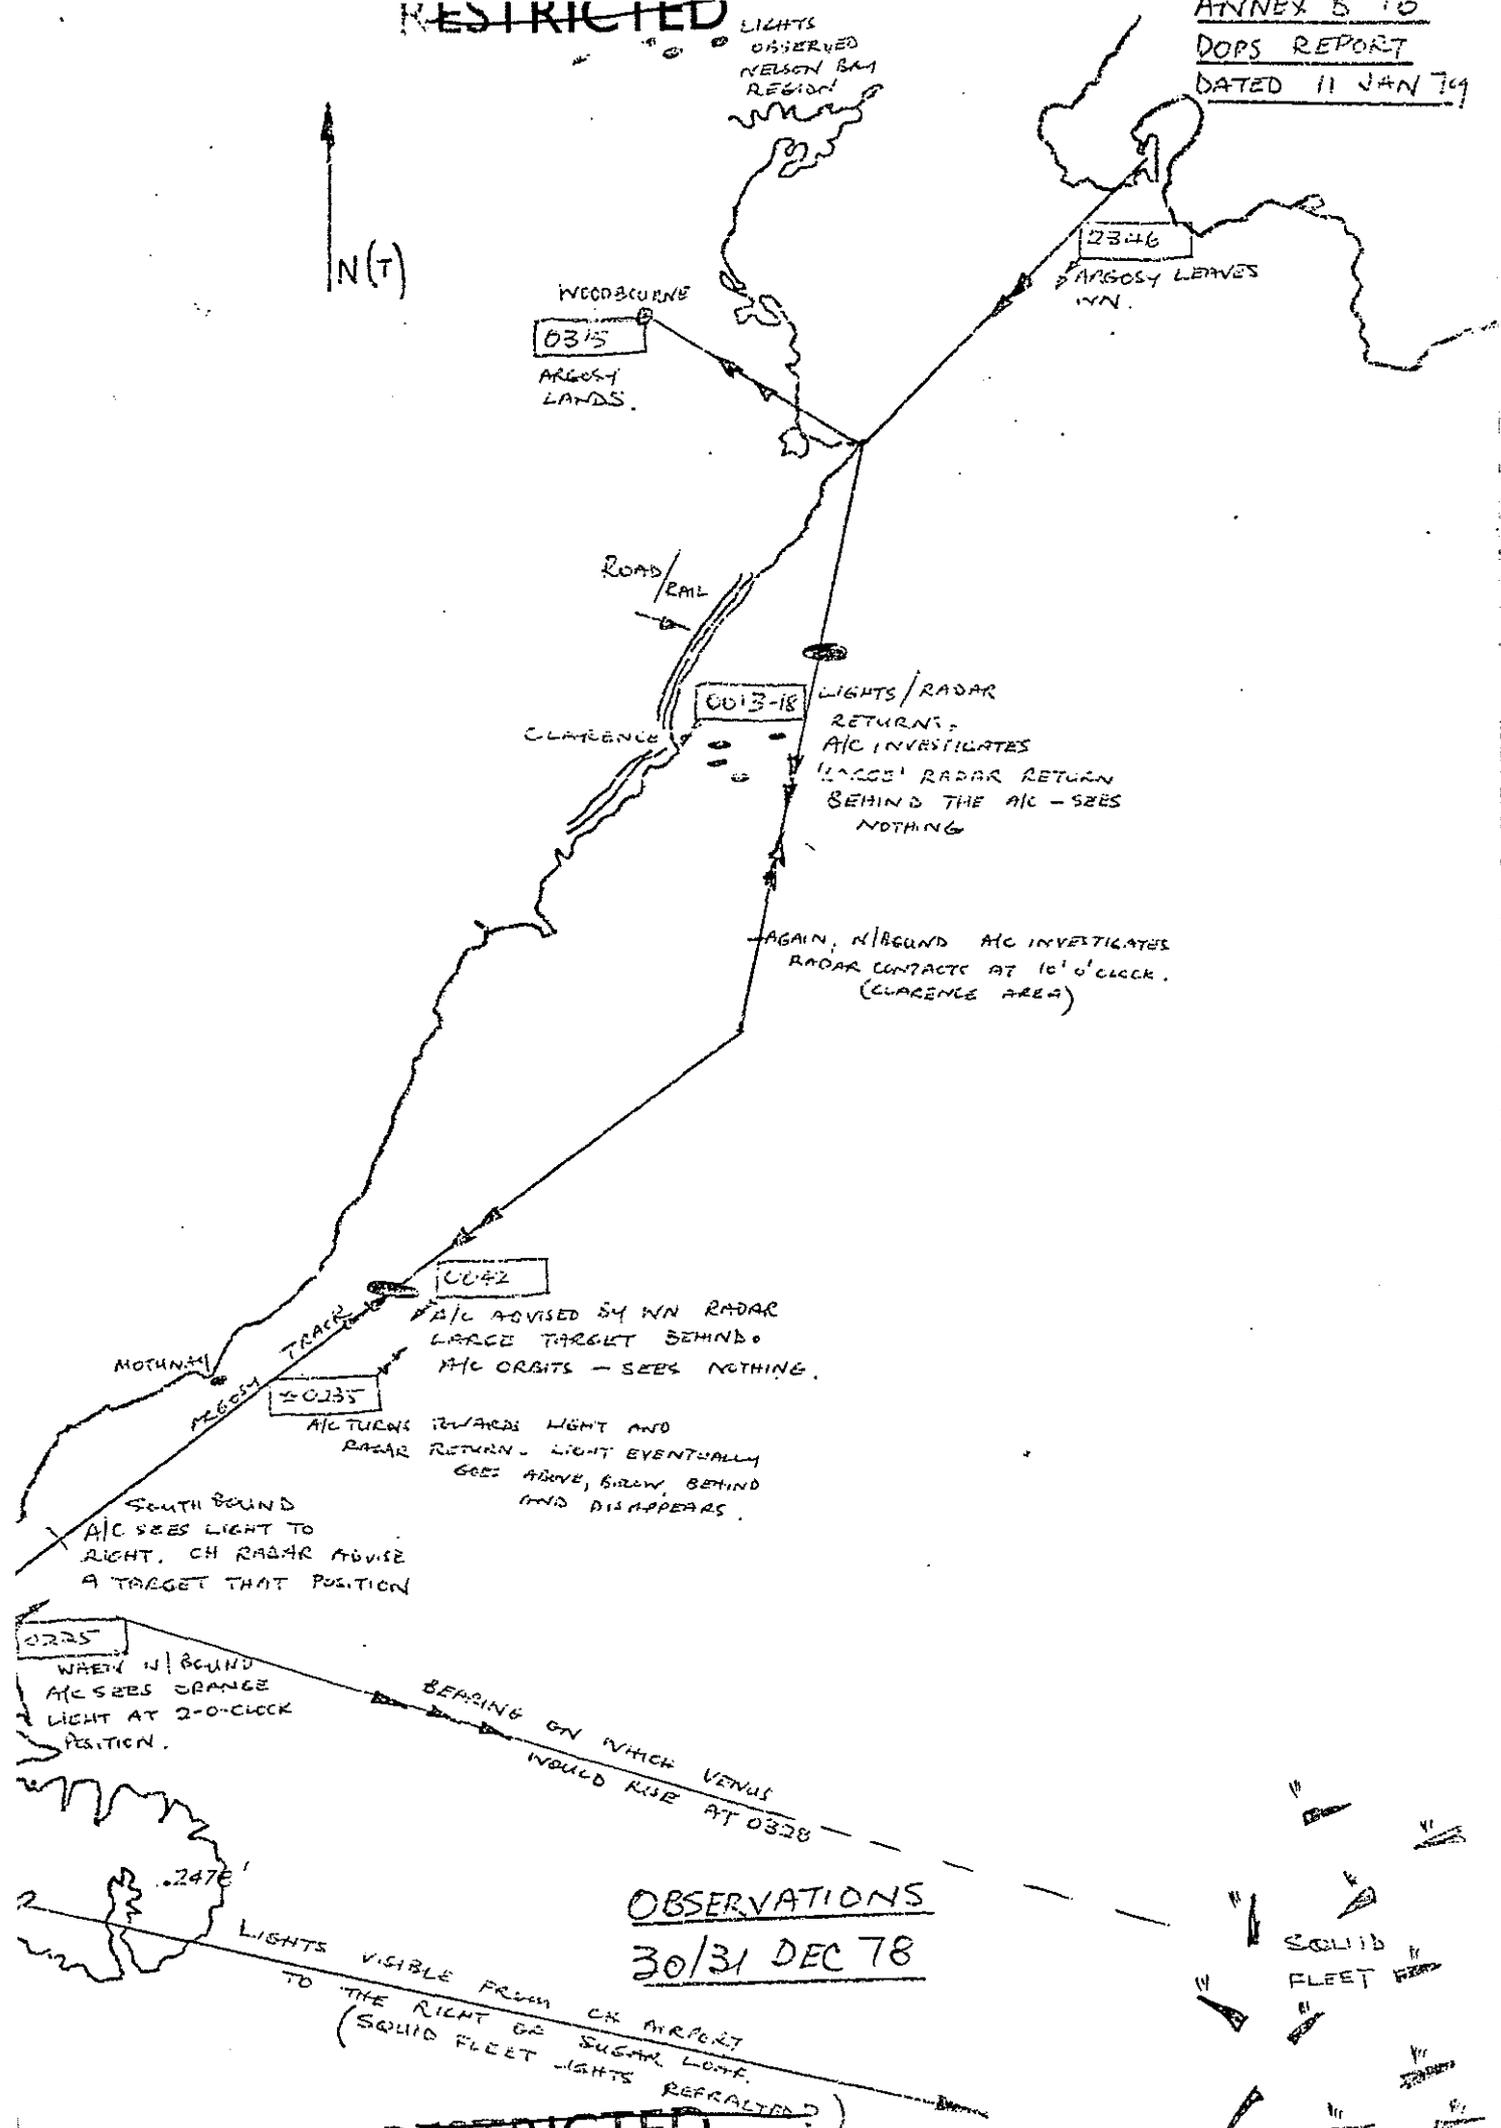
ANNEX 5 TO  
DOPS REPORT  
DATED 11 JAN 79

LIGHTS  
OBSERVED  
NELSON BAY  
REGION
