1
00:00:06,869 --> 00:00:03,750
at nasa's kennedy space center in

2
00:00:08,950 --> 00:00:06,879
florida technicians at launch pad 39a

3
00:00:11,190 --> 00:00:08,960
are working to repair small cracks on

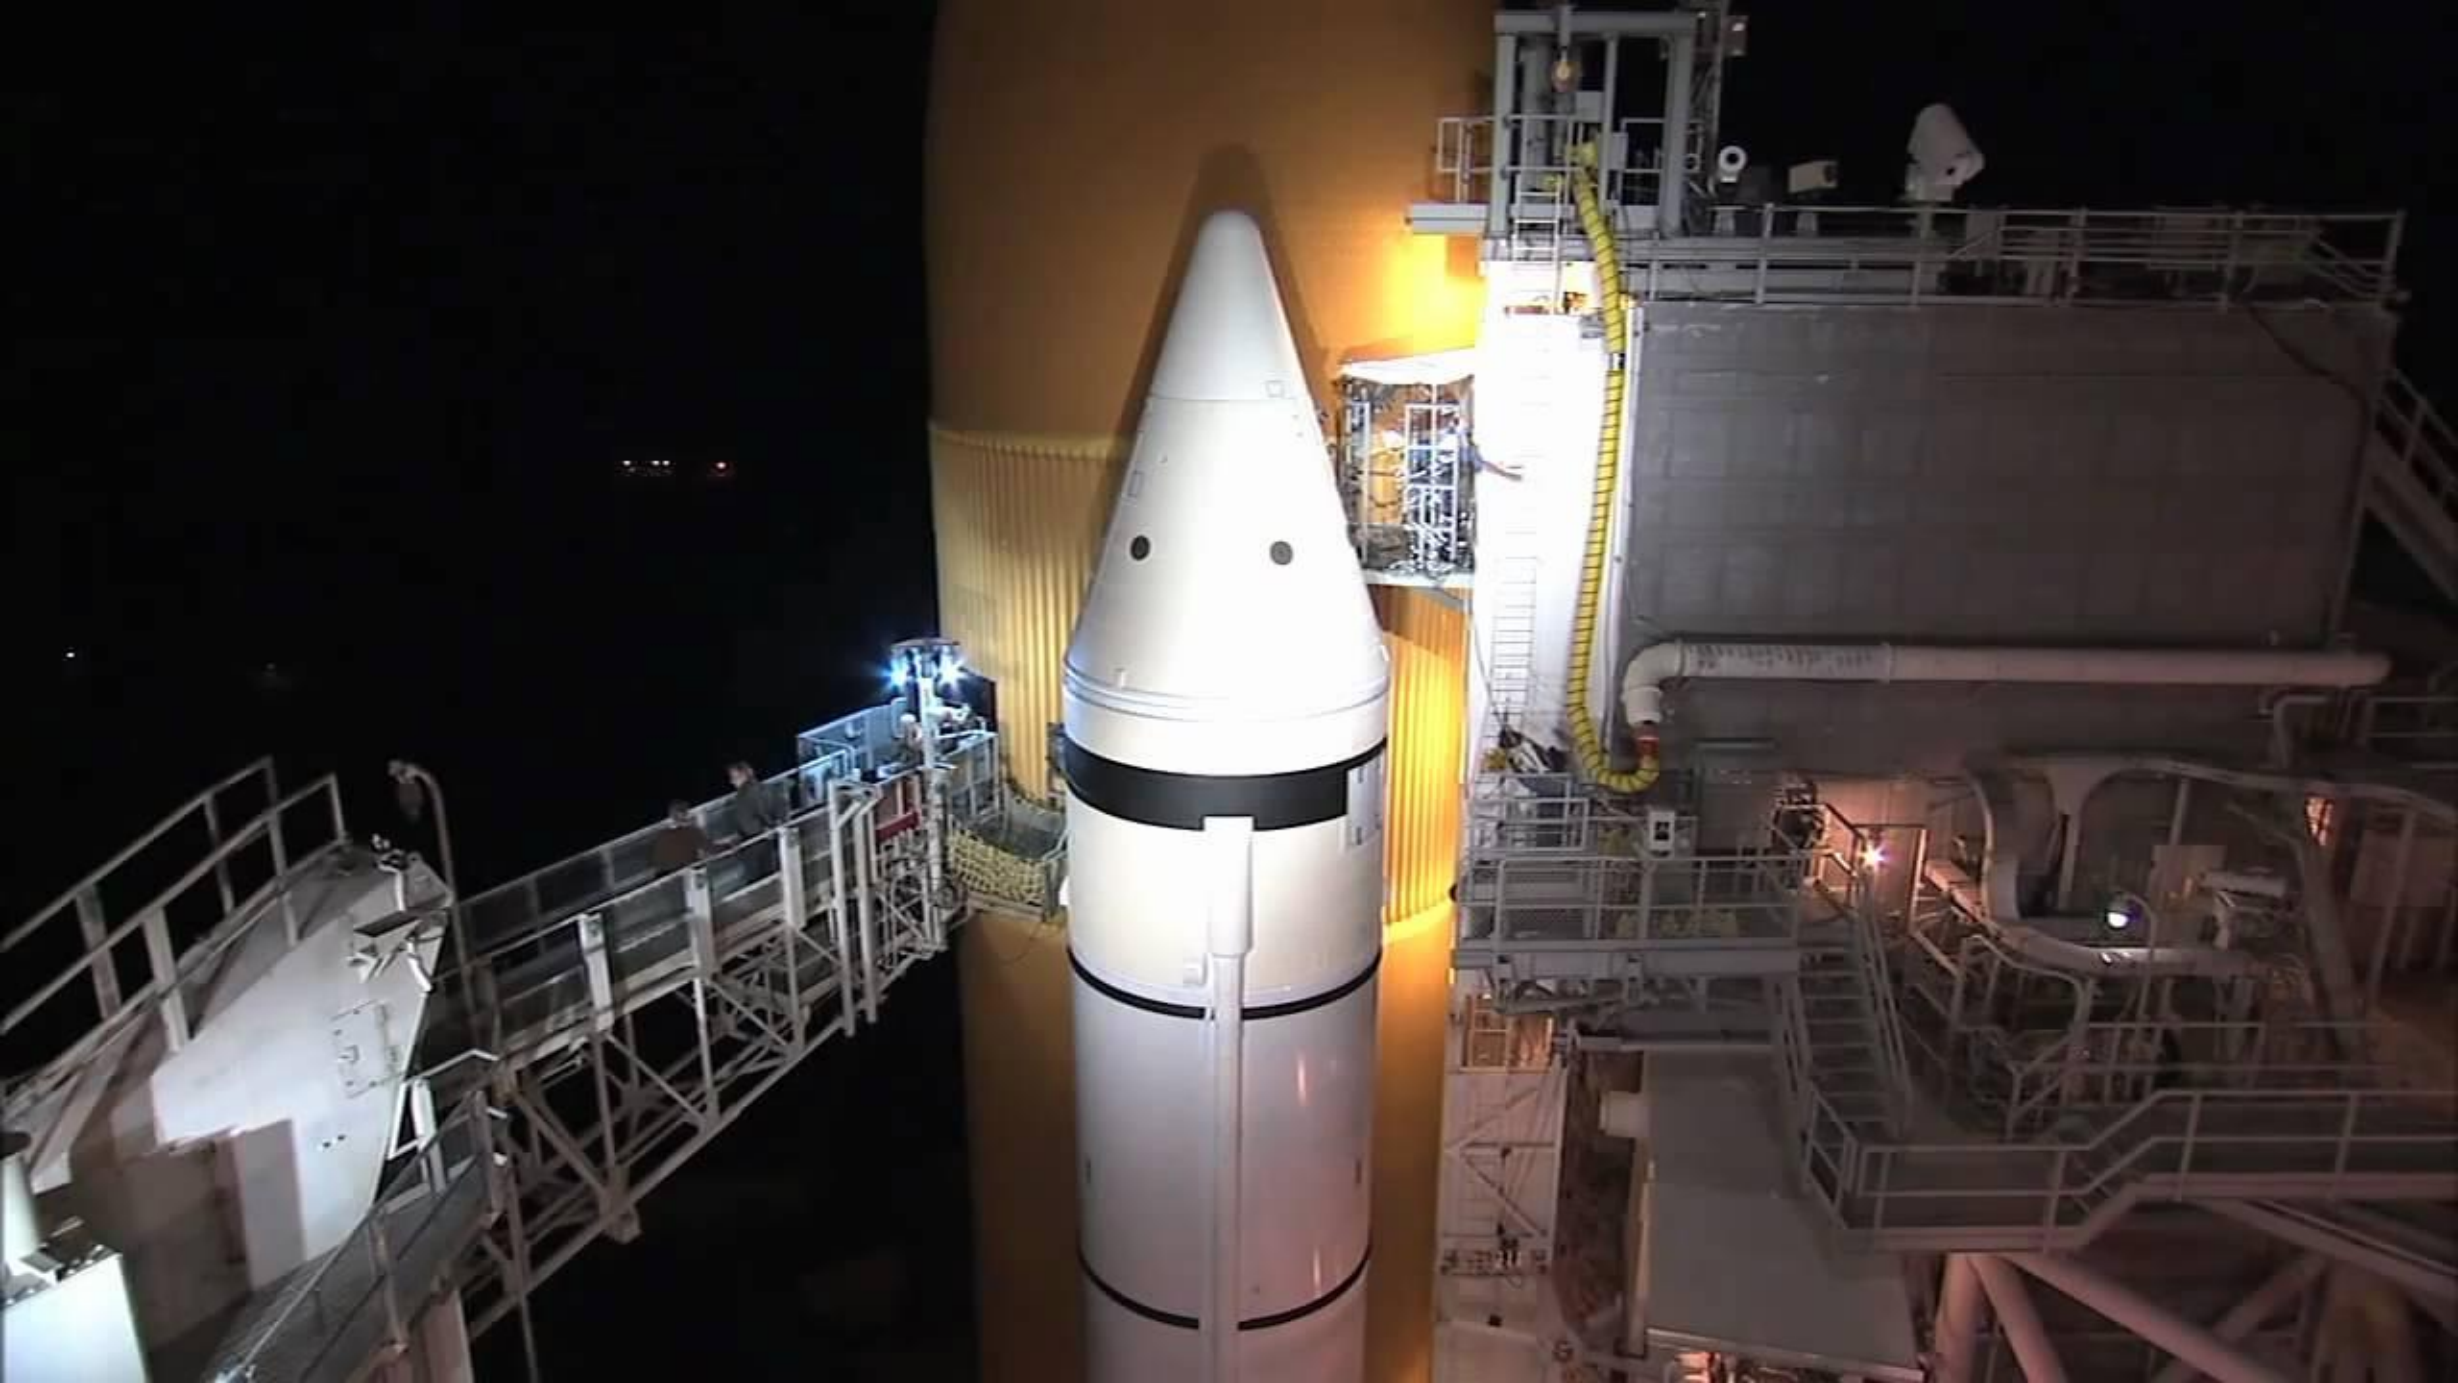
4
00:00:13,110 --> 00:00:11,200
the tops of two metal support beams

5
00:00:16,470 --> 00:00:13,120
called stringers on space shuttle

6
00:00:18,870 --> 00:00:16,480
discovery's external fuel tank teams

the stringer crack developed as the

external tank was being filled for

discovery's launch attempt on november

7
00:00:21,109 --> 00:00:18,880
have built an environmental enclosure in

8
00:00:23,029 --> 00:00:21,119
an area around the stringers which will

9
00:00:25,349 --> 00:00:23,039
provide the proper temperature and

10
00:00:27,349 --> 00:00:25,359
humidity when foam insulation is

11
00:00:29,830 --> 00:00:27,359
reapplied to the tops of the stringers

12
00:00:32,310 --> 00:00:29,840
following the repairs

video of a technician holding a new

section of middle called a doubler that

will be installed on the stringer as

part of the repair method it's called a

doubler because it's twice as thick as

the original stringer metal
