1
00:00:06,380 --> 00:00:04,070
at NASA's Kennedy Space Center in

2
00:00:08,690 --> 00:00:06,390
Florida technicians in the Vehicle

3
00:00:12,259 --> 00:00:08,700
Assembly Building make modifications to

4
00:00:14,329 --> 00:00:12,269
34 support beams call stringers on Space

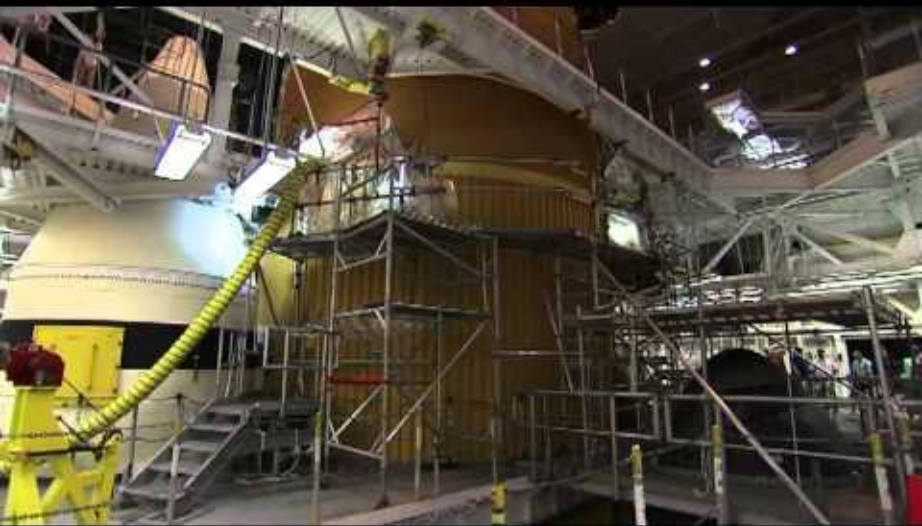
5
00:00:16,790 --> 00:00:14,339
Shuttle Discovery's external fuel tank

6
00:00:19,100 --> 00:00:16,800
to increase the structural support of

7
00:00:21,770 --> 00:00:19,110
the stringers crews fit pieces of metal

8
00:00:23,660 --> 00:00:21,780
called radius blocks over the tops of

9
00:00:26,600 --> 00:00:23,670
the stringers edges at the external

10
00:00:28,520 --> 00:00:26,610
tanks thrust panel area the thrust panel
